# **Assessing Deterioration of ADSS Fiber Optic Cables Due to Corona Discharge**

*Final Project Report*

George G. Karady, Project Leader  
Johnny Madrid, Researcher  
Arizona State University

PSERC Publication 02-17

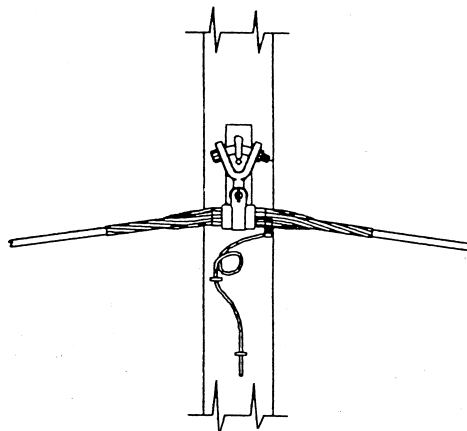
Figure 1. Armor rod assembly for fiber optic cables

Utilities frequently use ADSS (All Dielectric Self-Supporting) fiber optic cables installed on transmission lines 10-20 feet below the high voltage conductors. An armor rod assembly supports the cable at each tower as shown in Figure 1. The rods surround the cable and distribute the mechanical loads evenly. Discussions during an IEEE workshop indicated that the failure of ADSS fiber optic cables in high electric field environments is an industry-wide problem. Several corporations such as, Bonneville Power Administration, Houston Light and Power, Consolidated Edison, and others in England and Germany observed surface deterioration on ADSS cables installed on HV structures.

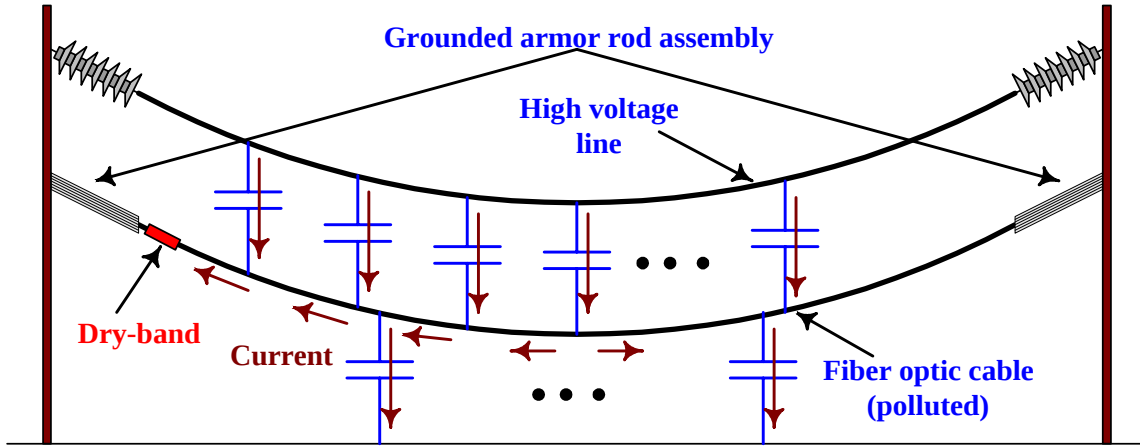
Figure 3. Fiber optic cable high voltage line configuration

A armor rod assemblies are attached to transmission line structures and support the fiber optic cables. The cables are effectively grounded to the earth through these suspension points via the structure's design. Depending on the placement of the cable with respect to the high voltage conductors, the conductor's voltage, and pollution on the cable's sheath an induced voltage and current will flow over most of the cable's suspended length. This type of configuration, as shown in Figure 3, gives rise to various physical phenomena, namely, corona, microsparking, and dry-band arcing, especially near the tower, as the current is greatest there [2]. Fiber optic cables strung in these electrically hostile environments must last for a predicted life in excess of 25 years [3]. An experimental setup is needed to verify and compare the expected lifetimes for various cable sheath materials under the influence of dry-band arcing as encountered in its natural environment.

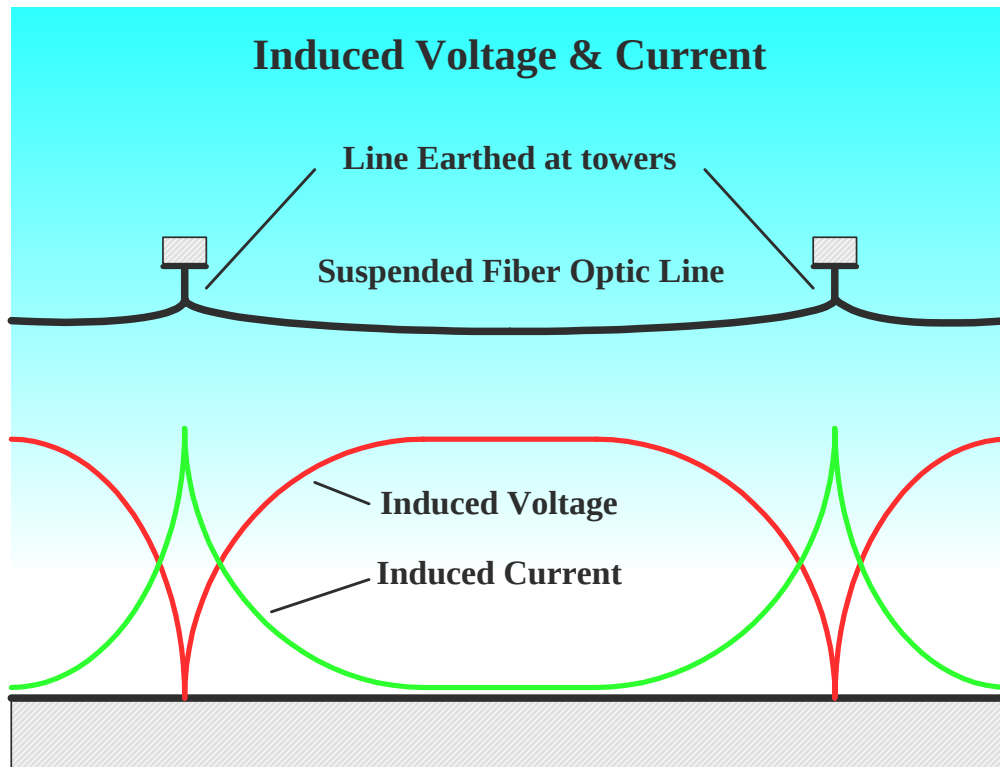
Figure 4. Induced voltage and current on a suspended fiber optic cable

Cables in service from various regions around the world, especially near coastal areas, have largely imputed failures to dry-band arcing. Dry-band arcing occurs on the outer sheath of fiber optic cables, even though the ADSS cable is electrically non-conductive. Dry-band arcing can be largely attributed to the contamination that accumulates on the outer sheath, which can be considerably conductive. One of the outer sheath's functions is to provide protection for the aramide material that is wrapped around another inner structure underneath the cable's outer sheath. The aramide material gives the cable its required tensile strength that allows the cable to be self-supporting. The aramide yarn is by far the strongest synthetic fiber next to a spider's web. Deterioration of the outer sheath will expose the aramide to the environment and degrade its tensile strength characteristics. Exposing the aramide material to arcing activity will cause degradation to occur by the high temperature of the arc. This will then lead to the fiber optic cables to drop out of service by collapsing under its own weight.

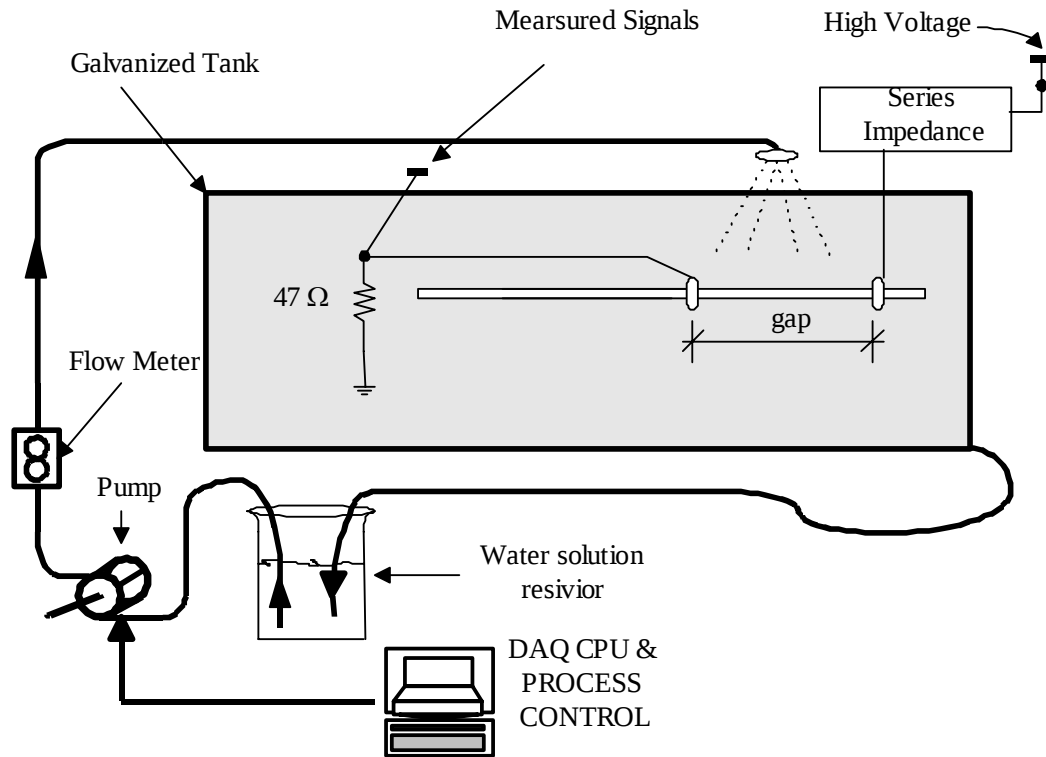
Figure 5. Apparatus for testing cable samples in the laboratory

The method used to characterize the cable degradation is based on the damage caused by the dry-band arcing occurring on the outer sheath of the cable. The fiber optic cables are installed in a laboratory test setup and energized to a specified high voltage. A water solution is sprayed periodically on the energized fiber optic cable by an automated computer system to initiate dry-band arcing and allowed to dry naturally. The most useful experimental apparatus for testing fiber optic cable sheaths against dry-band arcing is shown in Figure 5. This setup simulates the effects of dry-band arcing on the fiber optic cables as encountered in the field. In this setup, the high voltage and low voltage electrodes are fixed directly to the cable's sheath and a 60 Hz (AC) voltage is supplied to the high voltage electrode through a series current limiting impedance. Much care must be considered by making sure that the concentration of the NaCl (sodium chloride) water solution does not change drastically during the test. Changing the conductivity of the water solution may adversely change the rate of degradation of the cable's sheath for a fixed high voltage level. This change in conductivity increases the risk of introducing an aging mechanism that could be drastically different from the actual environment encountered by the ADSS fiber optic cable in service. Therefore the NaCl water solution concentration is kept as constant as possible.

An experimental test setup is described in [22], which uses a setup as shown in Figure 5. Subjecting the energized cables to an intermittent water spray induced dry-band arcing. The spray duration used in the setup discussed in [22] comprised of two seconds at two-minute intervals. The definition of failure is based on an subjective judgement. The stated failure is when sheath degradation has proceeded to a stage where the central cable core is just exposed, but no significant degradation of the core itself has occurred. Due to this objective definition of failure they considered ten samples and analyzed them using Weibull analysis.

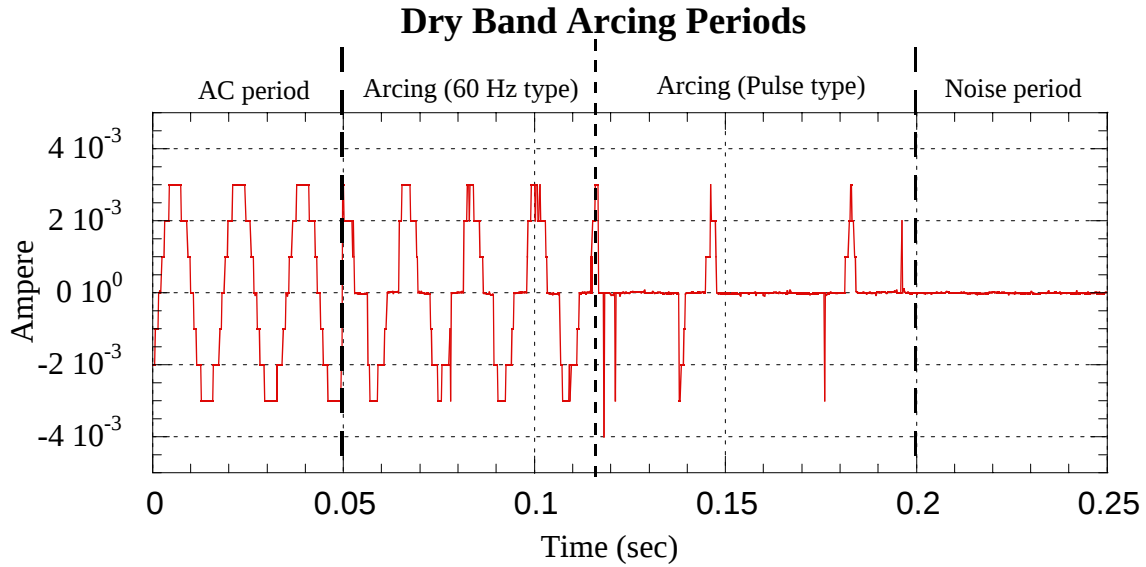
Figure 6. Dry-band arcing periods

The three periods that categorized above are shown in Figure 6. The two types of arcing events under the *Arcing period* have not been studied in detail in regard to the amount of damage caused on the cable's sheath.

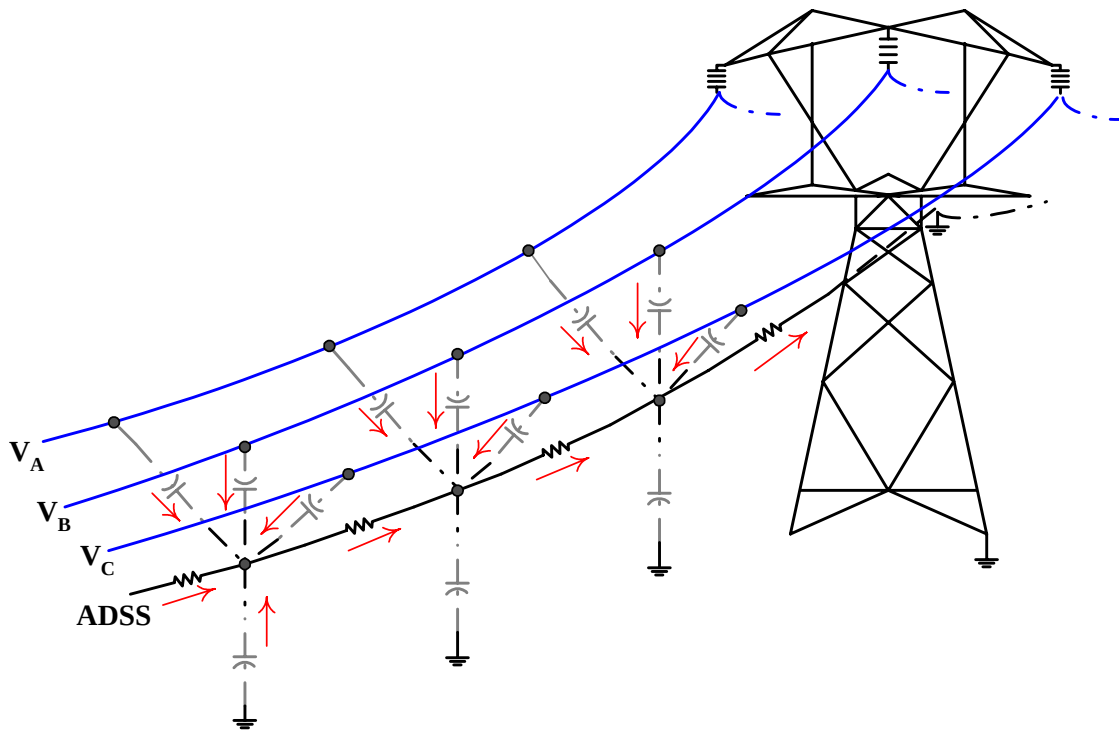
Figure 8. Representative Transmission and ADSS Circuit Model

Having a representative model enables further investigation of the physical metrics most dominating that affect the events leading to dry-band arcing under the aforementioned electrical environment. An in depth inspection of the analytical results gives rise to simplification of the total model.

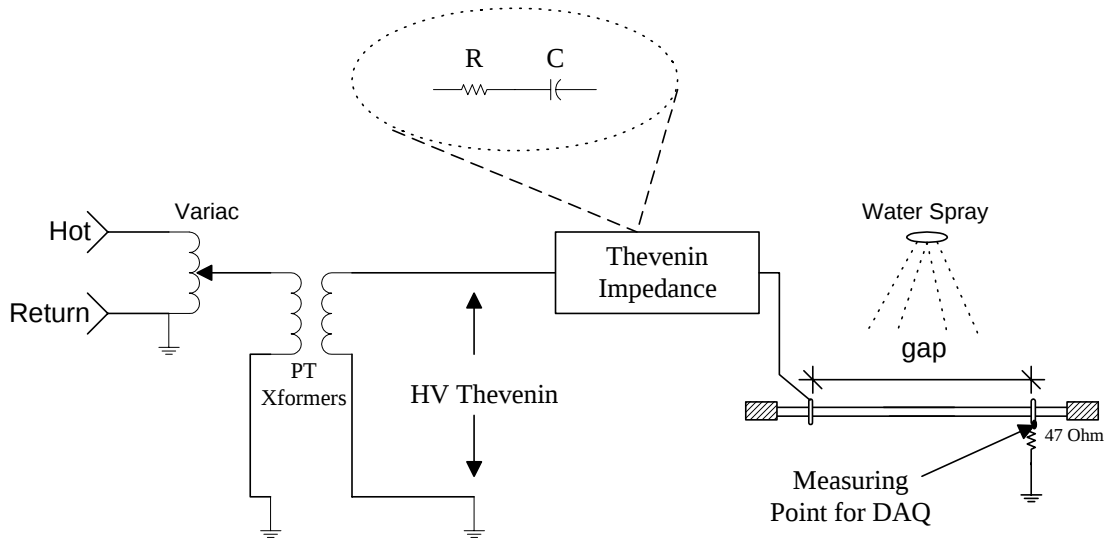
Figure 11. Implementation using equivalent Thevenin voltage and Thevenin impedance

The accumulated pollution may be relatively conductive and is represented as a sectional resistance of finite value,  $R_{0j}$ . The equivalent circuit in Figure 9 also shows the phase conductors labeled 1, 2, and 3. From this equivalent circuit model an additional important parameter may be obtained, namely the energy source voltage. The energy source is deduced by replacing the three-phase conductors and mutual capacitances by a Thevenin equivalent source. Representing the energy source by a Thevenin equivalent circuit simplifies calculation and gives the key voltage and capacitance values practicable in an experimental test. The Thevenin equivalent is basically a single-phase system reduced from the three-phase equivalent circuit of Figure 9. The single-phase equivalent circuit is shown in Figure 10. The other key parameter obtained from the analysis of the equivalent is the prototypical values of polluted fiber optic cable. With these three values of voltage, source capacitance, and polluted cable resistance enables the implementation of a laboratory setup to simulate the electrical effects experienced by a fiber optic cable near the high voltage conductors in a power transmission network. Note that the capacitively induced current that flows along the polluted cable sheath is driven by the electric field radiated from the high voltage power lines. The induced current magnitude will also be a function of the pollution level on the fiber optic cable's sheath. The equivalent circuit can be represented and implemented as shown in Figure 11.

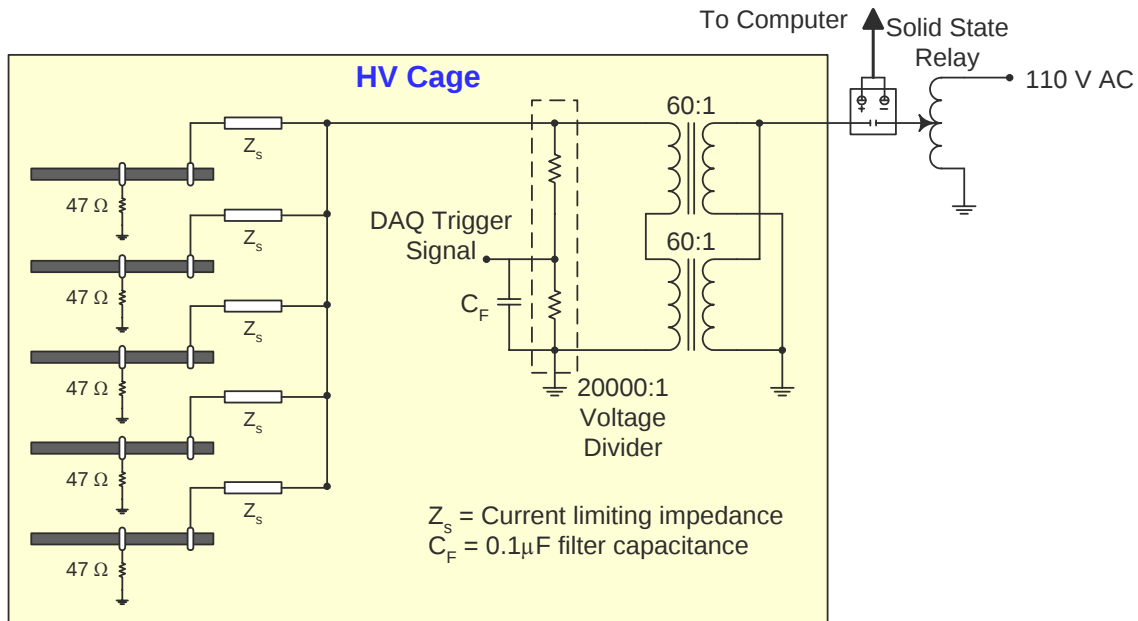
Figure 12. Electrical setup

To simulate environmental conditions representative of the fiber optic cable's posture on high voltage networks, an experimental setup subjects the cables to particular preconditions for dry-band arcing to occur. An experimental setup was built indoors in Arizona State University's Instrumentation Laboratory. Figure 12 shows the high voltage electrical connections and Figure 5 shows the experimental setup. The water reservoir contains water that may contain NaCl to simulate the effects of the surrounding polluted environment and the flow rate is measured using an in-line flow meter. The entire setup was placed in a grounded cage to prevent personnel to come in contact with the high voltage. A PC equipped with a National Instruments™ multifunction IO (input/output) card and LabVIEW™ software is used to control the high voltage electrical system, the pump system, the data acquisition system (DAS), plus a set of safety features [26]. This setup is designed to accommodate up to five cables to be tested simultaneously.

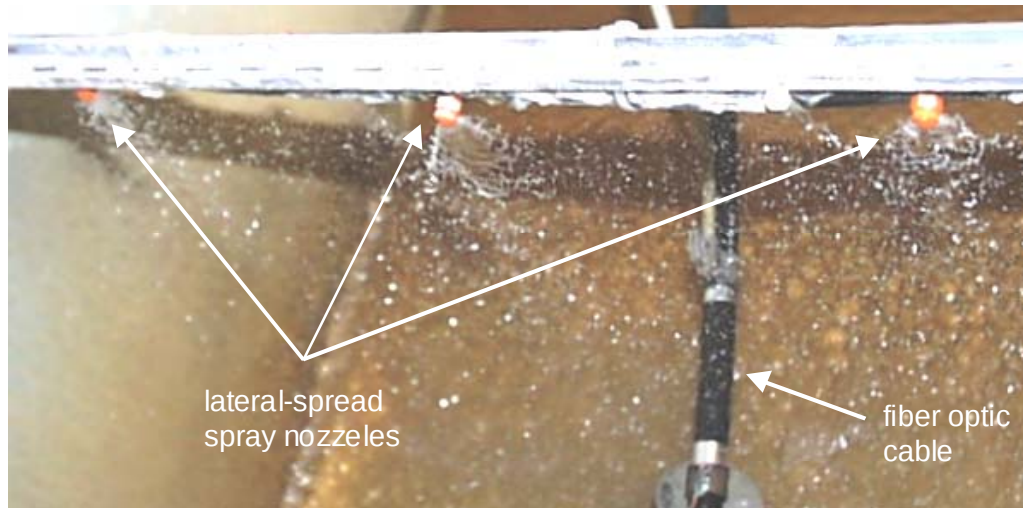
Figure 13. Brand-new spray pattern

To simulate the environmental conditions of rain, salt-water solutions were sprayed onto the cables. The pump periodically sprayed salt-water on the cables every five minutes; 1.5 minutes on and 3.5 minutes off, using two nozzles for the tests reported in the "Half Yearly Report 1 For 1999". Test performed later had shorter spray cycles and a modified spray pattern, consisting of five lateral-spread nozzles. This technique is depicted in Figure 13. The figure shows the top view of three spray nozzles. Two other nozzles are on the other side (not shown) are equally spaced in between the three shown in the figure. The figure shows the water solution being sprayed.

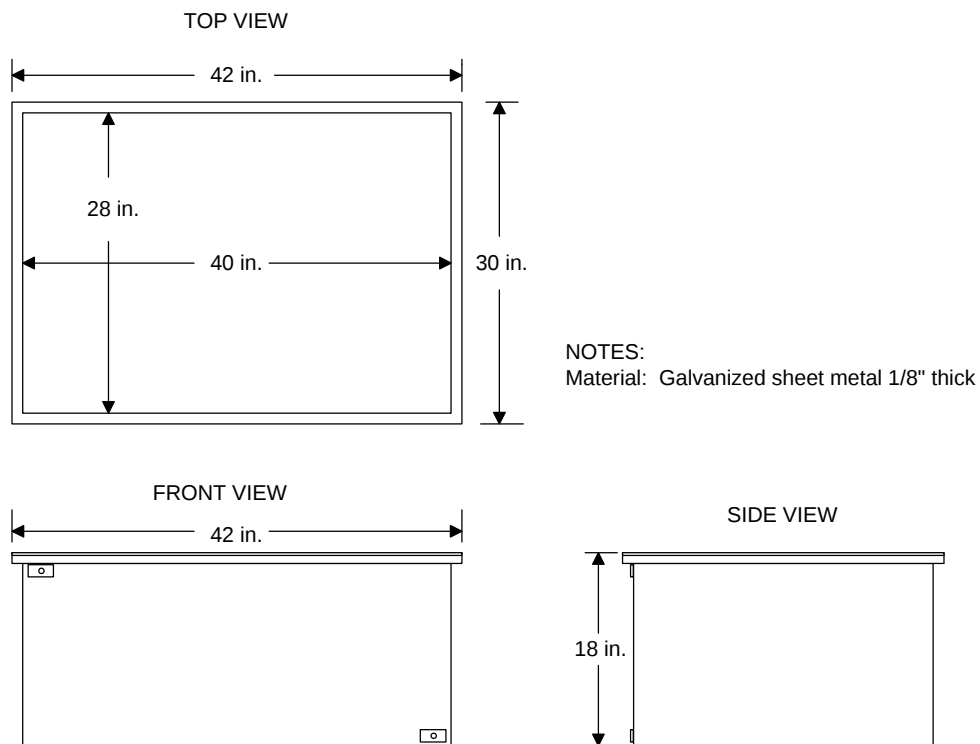
Figure 14. Galvanized metal tank used in the test setup

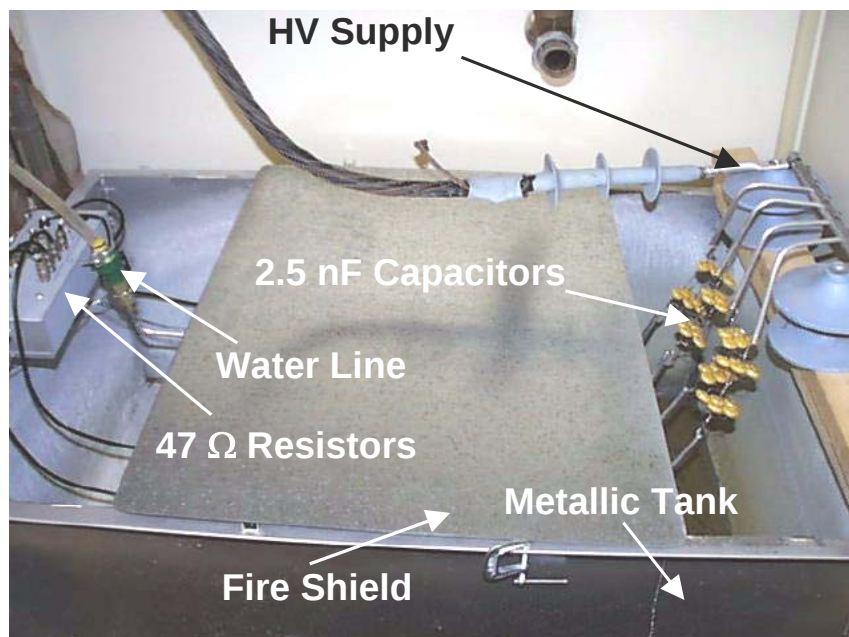
Figure 15. Photograph of test setup with 2.5 nF capacitors and fire shield

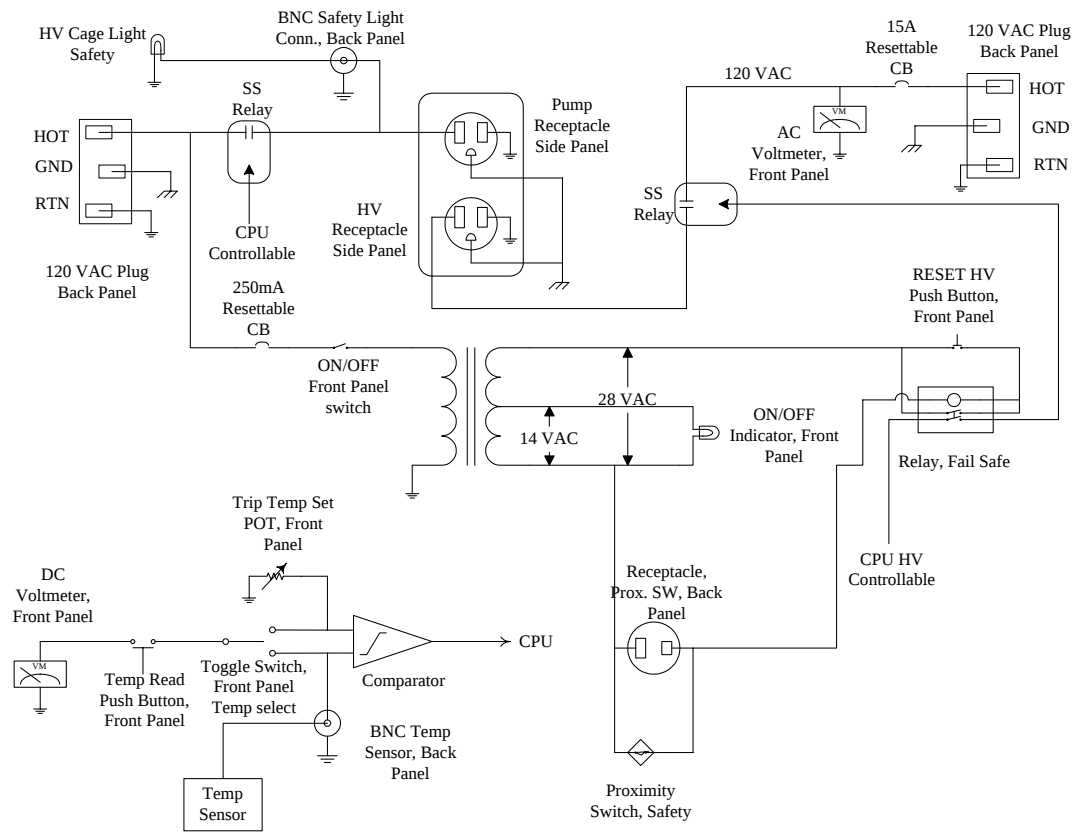
Figure 17. HV Control interface one-line diagram

Figure 17 shows a one-line diagram of the *Interface HV Control Box*. The lower left corner shows a comparator that monitors the set trip temperature and the actual temperature near the cable under test inside the galvanized metallic tank. This is one of the safety features included in the test setup. The comparator sends a transistor-transistor-logic (TTL) signal to the computer that corresponds to a high or low signal that depends on the relative comparison of the temperature sensor's output and the set temperature set point. The actual schematic of the *Interface HV Control Box* is shown in Appendix A. Figure 18 shows the cable suspension safety feature. If the cable were to catch fire and spread to the nylon string, the string will burn and the cable under test will drop into the galvanized metallic tank. The temperature sensor will sense the increase in temperature and send its output signal to the comparator mentioned above to be compared to the trip temperature.

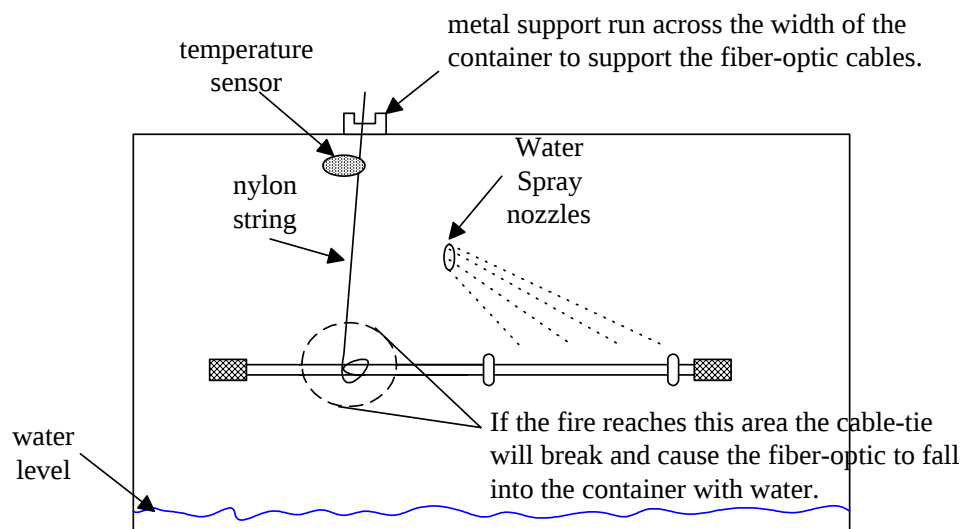
Figure 18. Cable suspension protection scheme

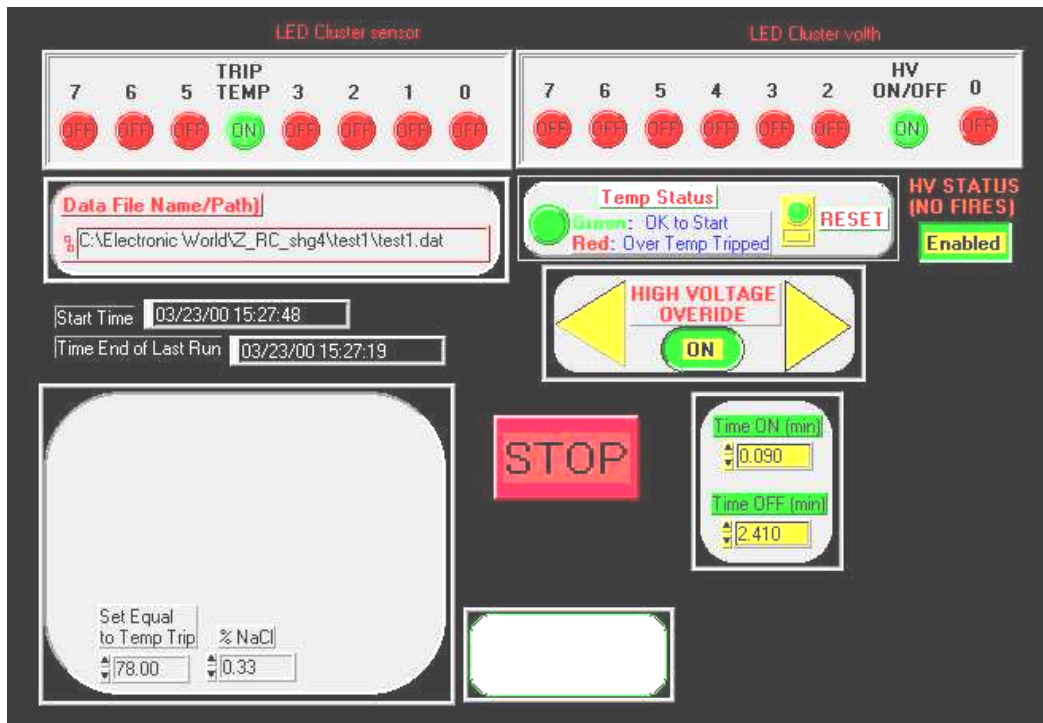
Figure 19. LabVIEW™ front panel for controlling the experiment

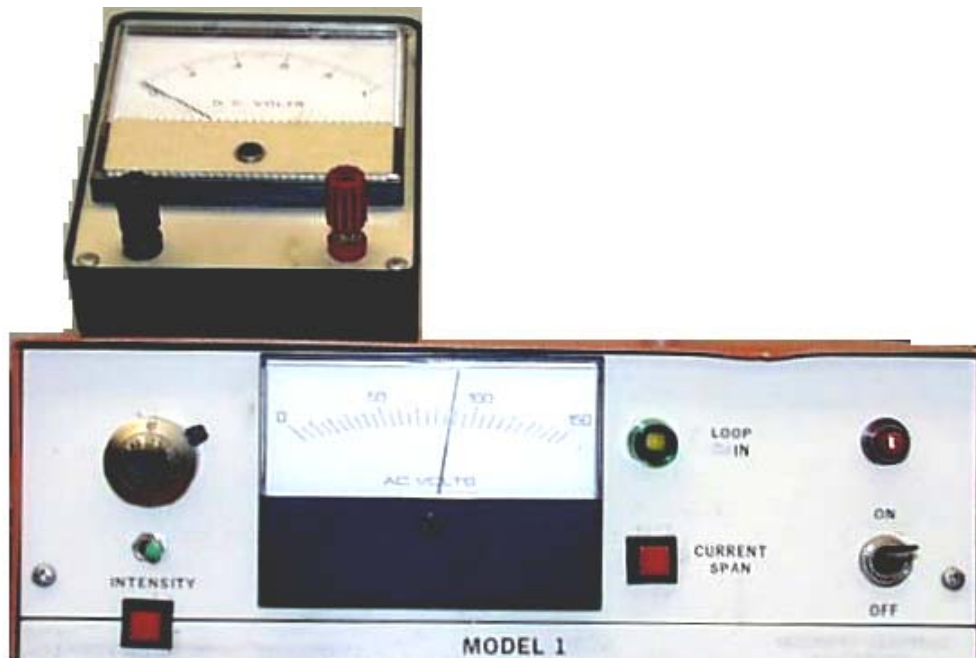
Figure 20. HV Control Interface Box, Front Panel

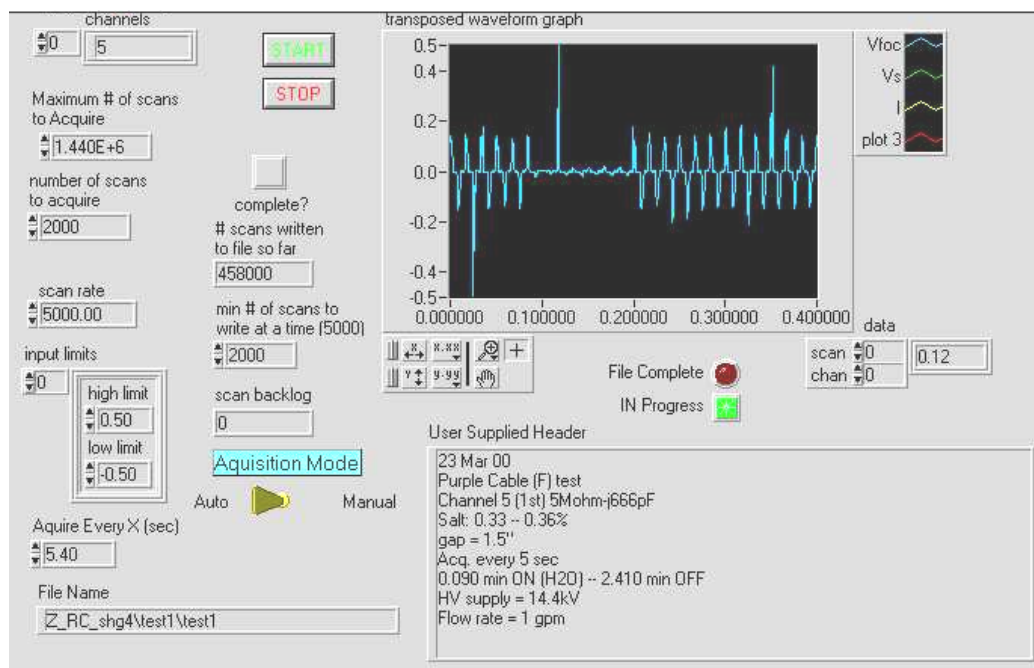
Figure 21. LabVIEW™ front panel for recording leakage current data

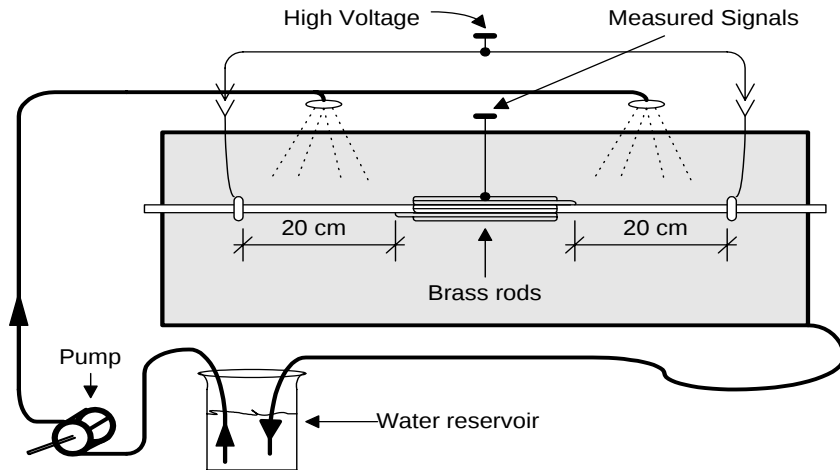
Figure 22. Original test setup with armor rod assembly and electrodes

1. Voltage: 14.4 kV<sub>rms</sub>.
2. Short circuit current: 5.4 A @ 15 kV (Without limiting impedance)

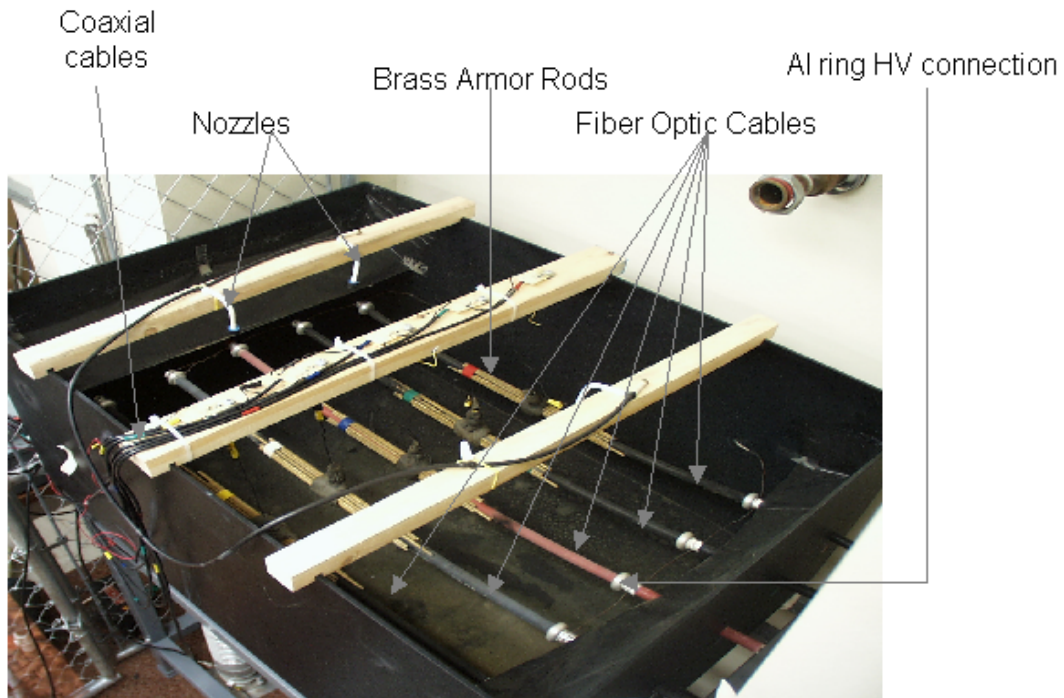
Figure 23. Top view of original experimental setup

The five cables were installed in the open plastic container and energized to 14.4 kV<sub>rms</sub> without any series limiting impedance as shown in Figure 23. The cables were periodically sprayed with tap water as explained before. The test results are shown in Table 3.

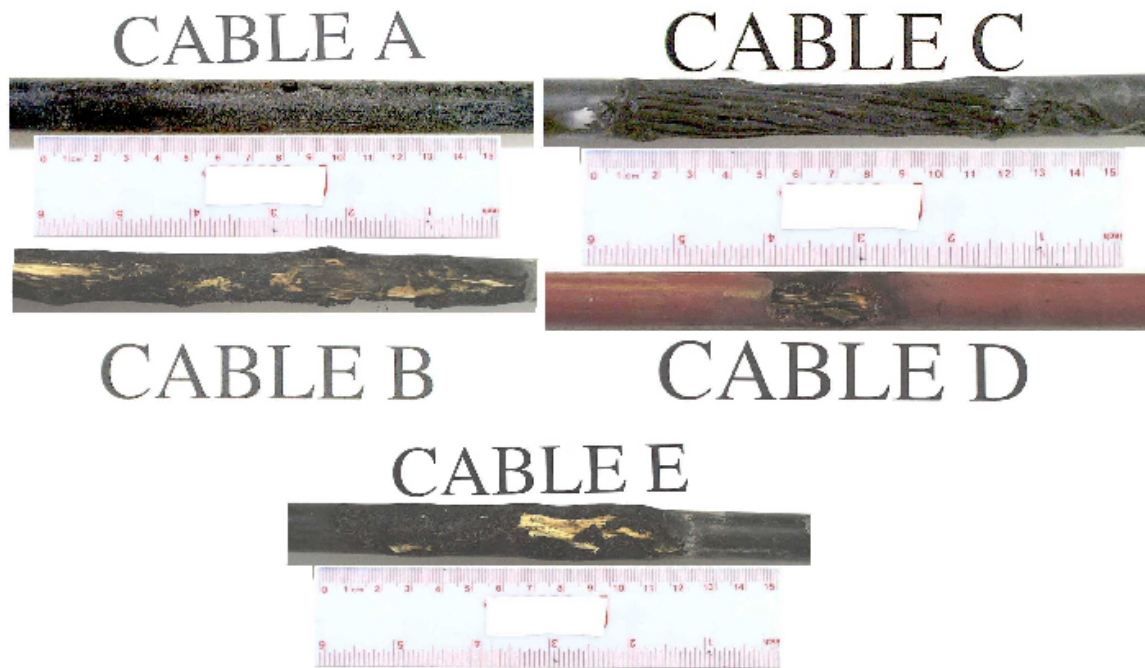
Figure 24. Series 1: damaged cable samples

others were punctured. The burning disintegrated the jackets. Figure 24 shows the damaged cables after completion of the test.

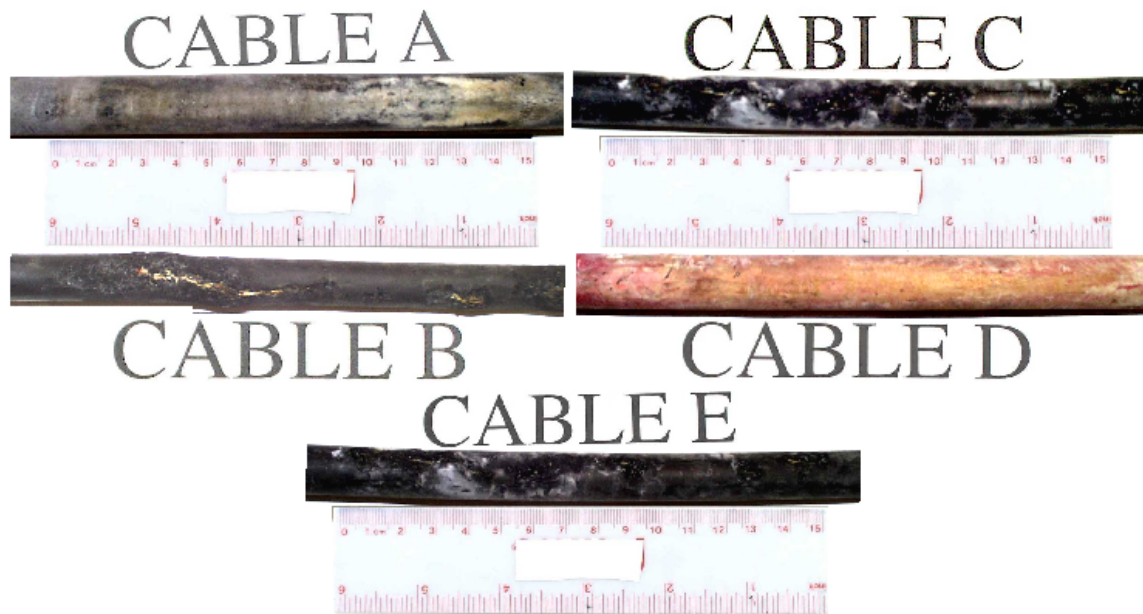
Figure 25. Series 2: damaged cable samples

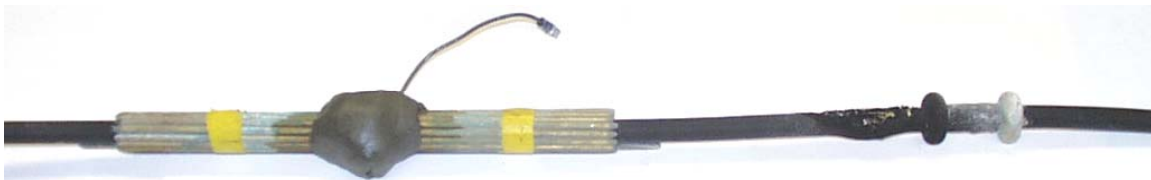
Figure 26. New and improved test object electrode arrangement

2. It was observed that the test cables were damaged on only one side, even though the two sides were visually symmetrical. The test object was built using only one 20 cm gap. Figure 26 shows the new test object with mounted electrodes.
3. The conductive water caused electrical activity to occur outside the cage. Arcing was observed on the water pump. This was a potential health hazard. The acrylic plastic tank was replaced with the galvanized metal tank, described in Chapter 3, and the system was rebuilt. Grounded metal pipe sections were used to eliminate outside arcing. Figure 27 and Figure 28 show the new test arrangement from the outside and the inside.
4. It was visually observed that the discharge stops for a few minutes during the dry part of a water cycle. Hence, the dry cycle was shortened to 3 minutes. The new water cycle was now 2 minutes wet and 3 minutes dry.

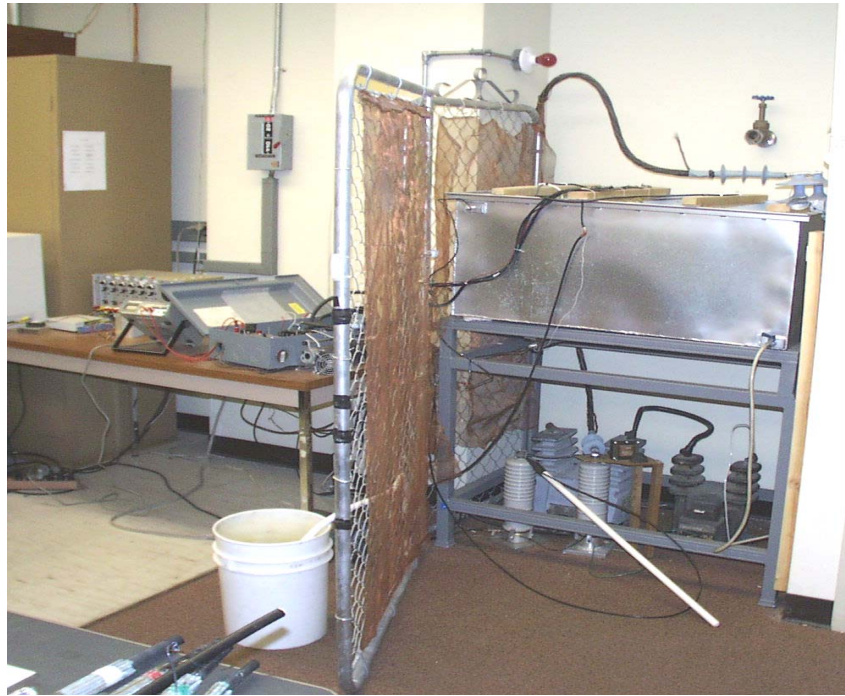
Figure 27. New and improved test arrangement

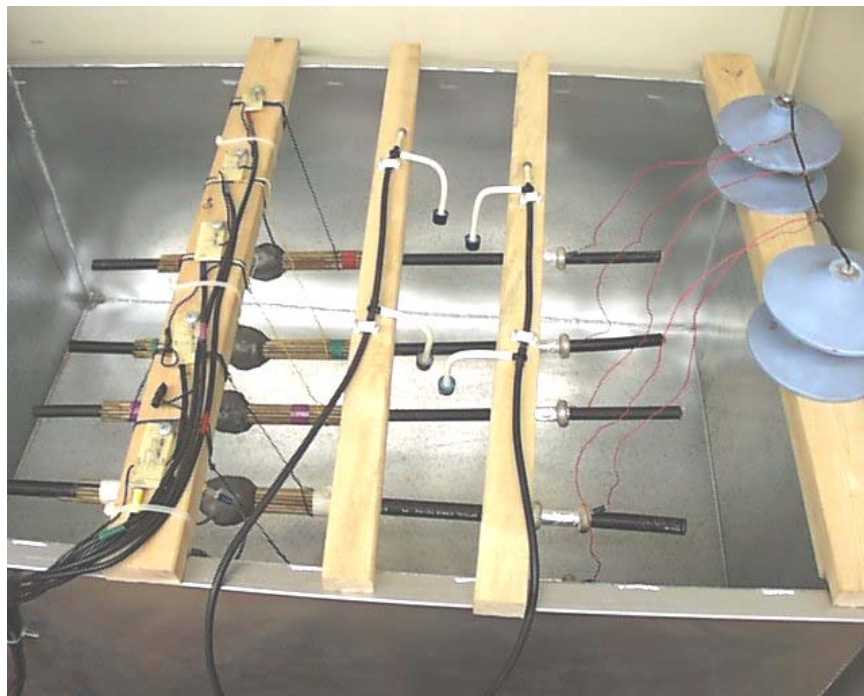
Figure 28. Inside view of new and improved test arrangement

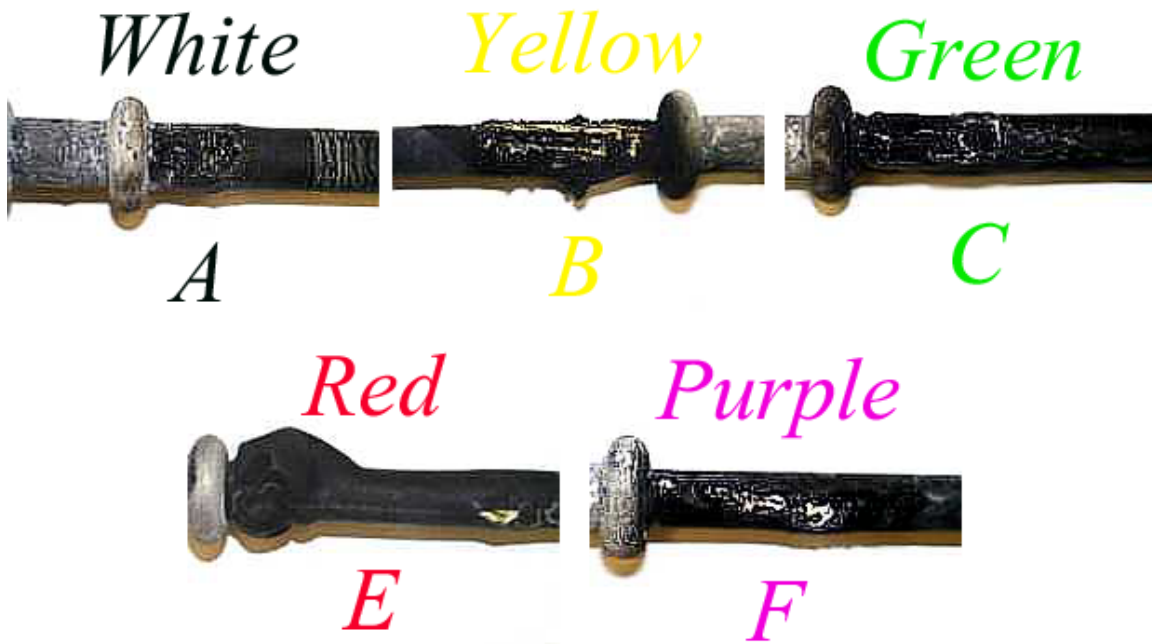
Figure 29. Series 4: damaged cable samples

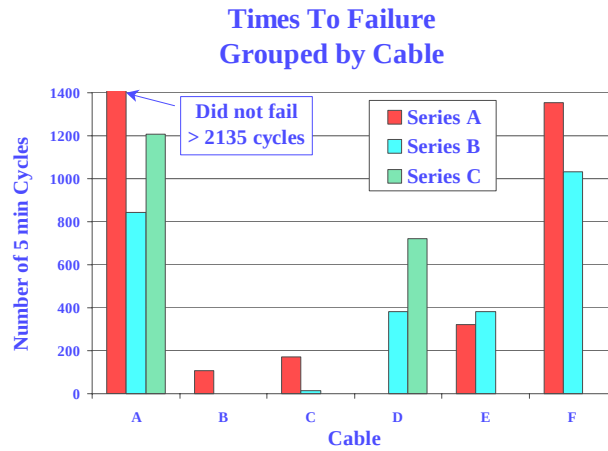
Figure 30. Series A – C; time-to-failure grouped by cable

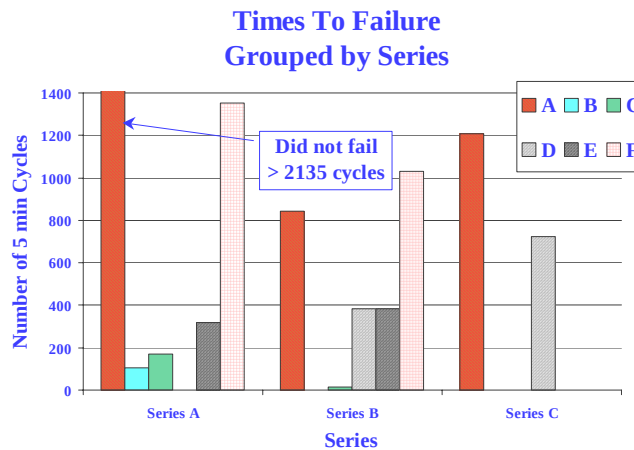
Figure 31. Series A – C; time-to-failure grouped by series

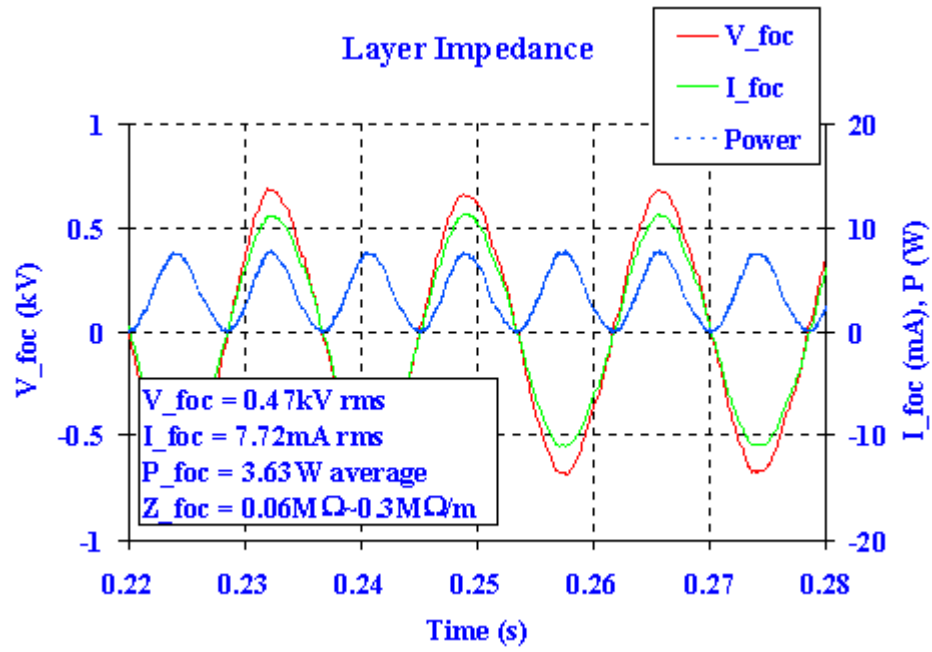
Figure 32. Voltage and current measurements on layer impedance

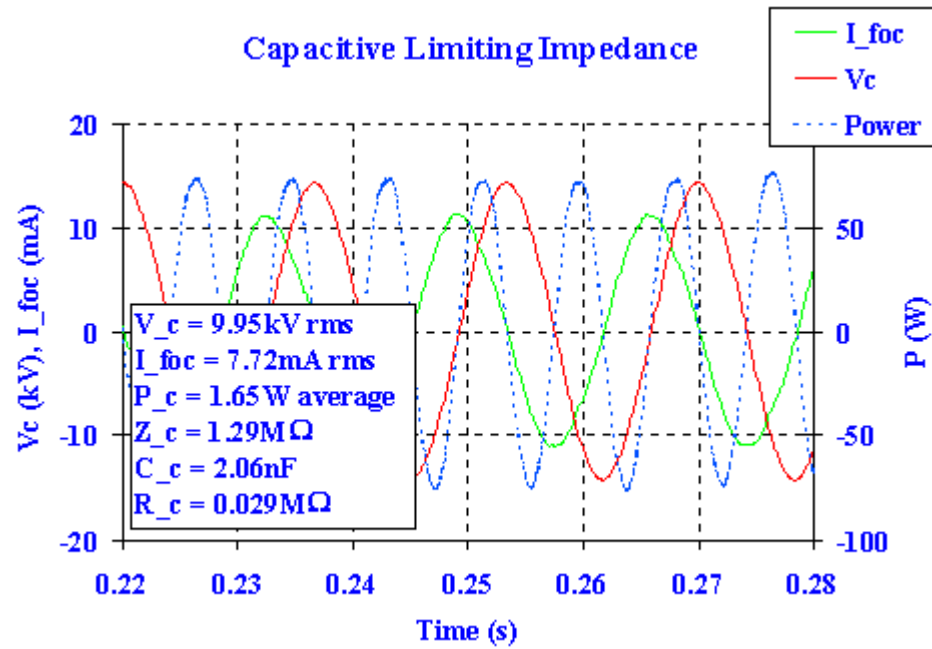
Figure 33. Voltage and current measurements on capacitive impedance

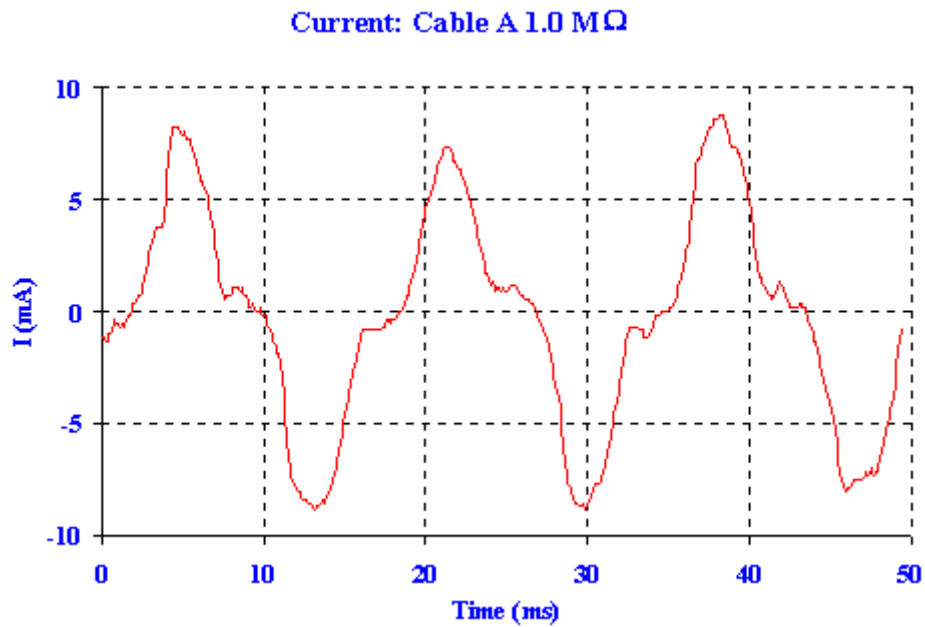
Figure 34. Current: Cable 'A', 1.0 M $\Omega$ , arcing

The current in the capacitance case has shorter bursts of energy than the resistance case during the dry-band arcing event. The amplitude is also larger for the capacitance case than the resistance case. Figure 38 shows the progress of the current waveform before arcing, at the onset of arcing, and during steady arcing. The oscillograms in Figure 38 show waveforms of the current through cable 'A' with a 2.5 nF limiting impedance. The current amplitude is limited to about 15 mA at the onset of arcing. The current increases to 30 mA during steady arcing.

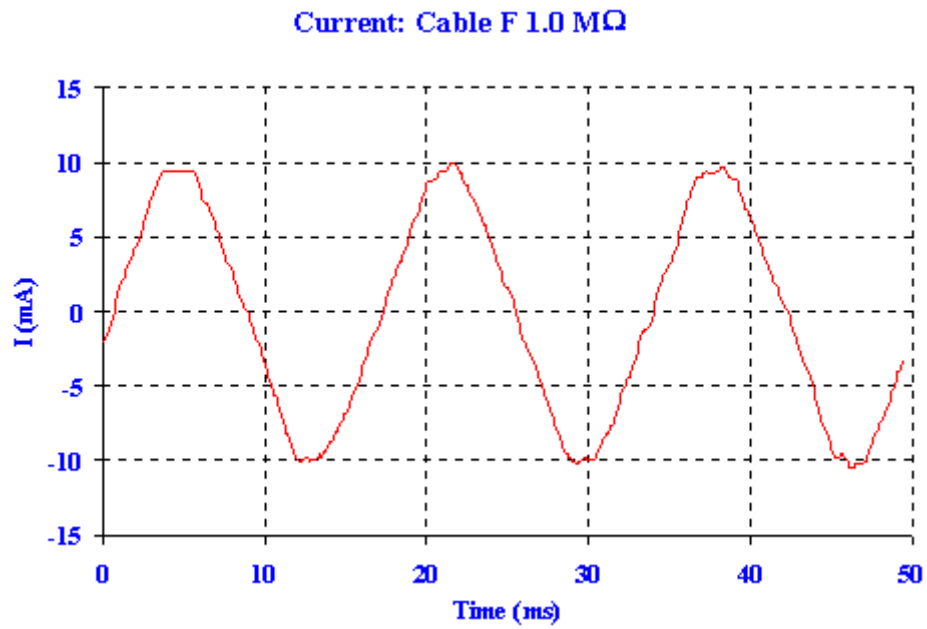
Figure 35. Current: Cable 'F', 1.0 M $\Omega$ , no arcing

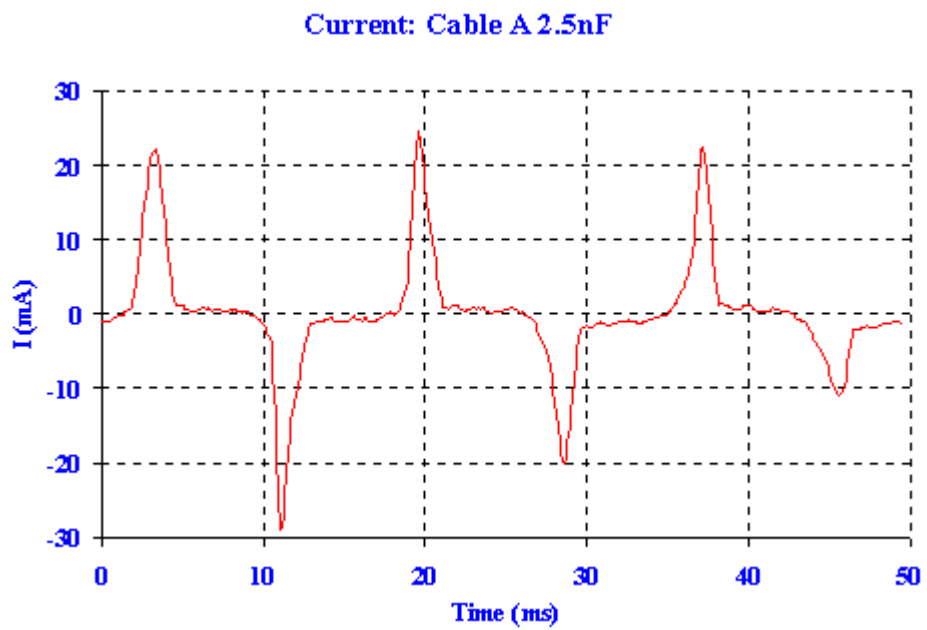
Figure 36. Current: Cable 'A', 2.5 nF, arcing
