# **Assessing Deterioration of ADSS Fiber Optic Cables Due to Corona Discharge**

*Final Project Report*

George G. Karady, Project Leader  
Johnny Madrid, Researcher  
Arizona State University

PSERC Publication 02-17

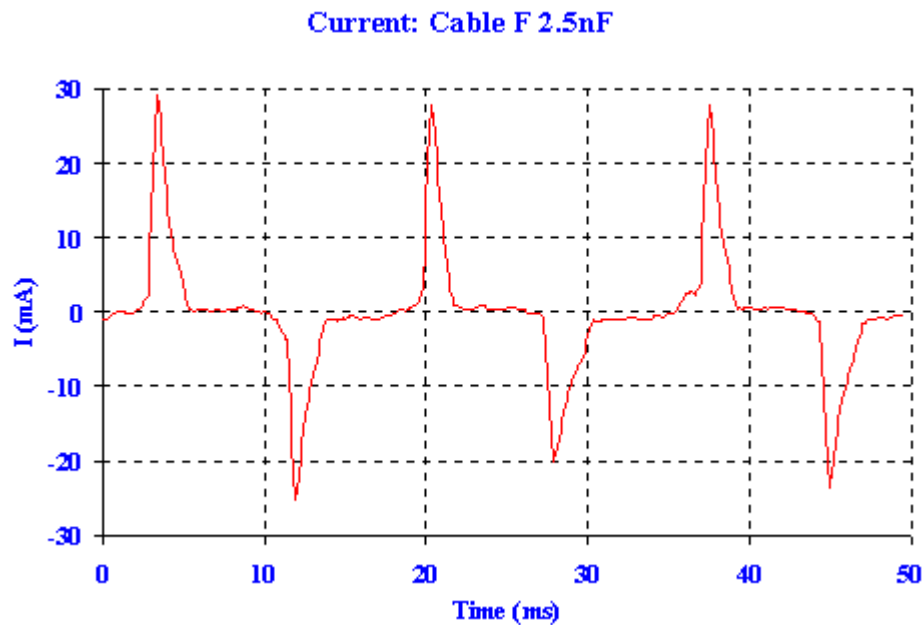
Figure 37. Current: Cable 'F', 2.5 nF, arcing

The current in the capacitance case has shorter bursts of energy than the resistance case during the dry-band arcing event. The amplitude is also larger for the capacitance case than the resistance case. Figure 38 shows the progress of the current waveform before arcing, at the onset of arcing, and during steady arcing. The oscillograms in Figure 38 show waveforms of the current through cable 'A' with a 2.5 nF limiting impedance. The current amplitude is limited to about 15 mA at the onset of arcing. The current increases to 30 mA during steady arcing.

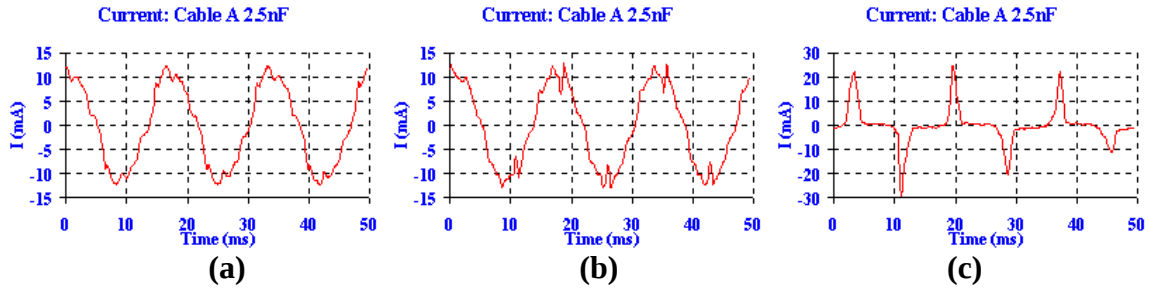
Figure 38. Arc current in cable ‘A’: (a) before arcing, (b) onset of arcing, (c) steady arcing

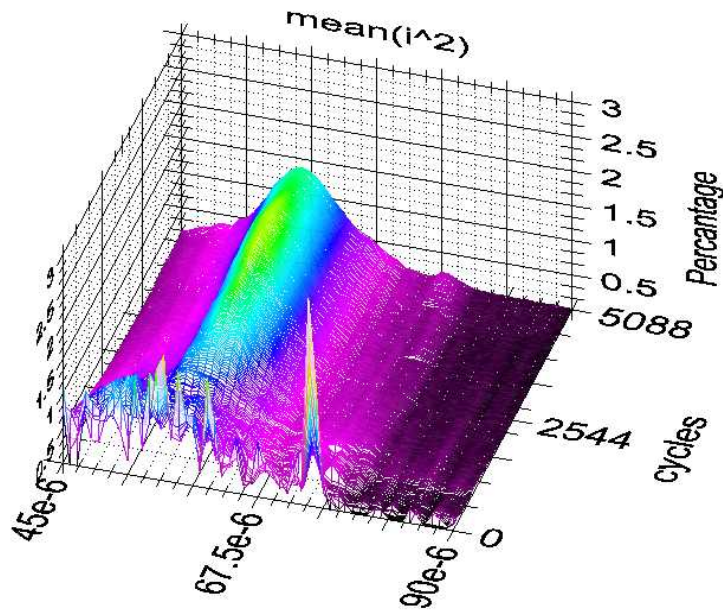
Figure 39. Series I: 2.5 nF *imsq* distribution (a) all, (b) 45e-6 to 90e-6

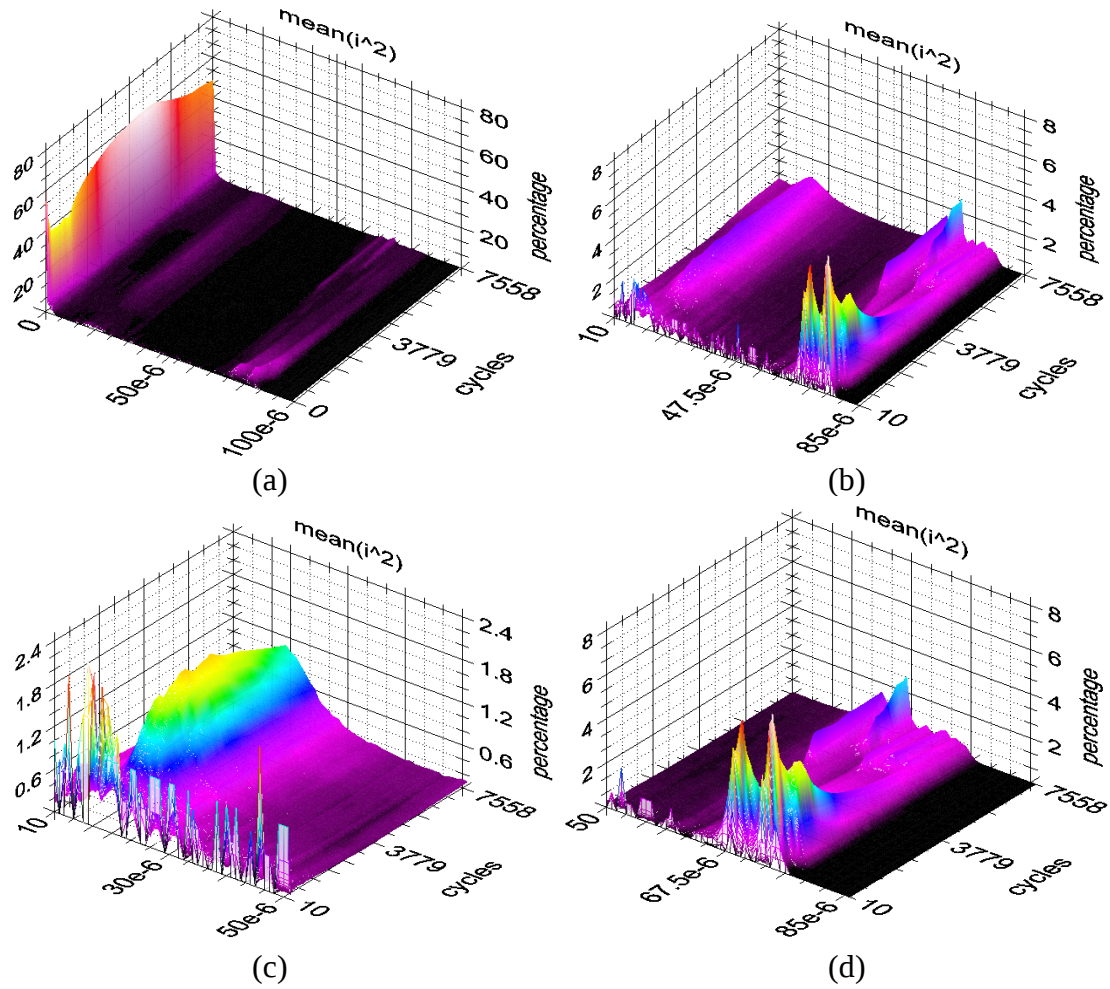
Figure 40. Series I: 1.0 M $\Omega$  *imsq* distribution (a) all, (b) 10e-6 to 85e-6, (c) 10e-6 to 50e-6, (d) 50e-6 to 85e-6

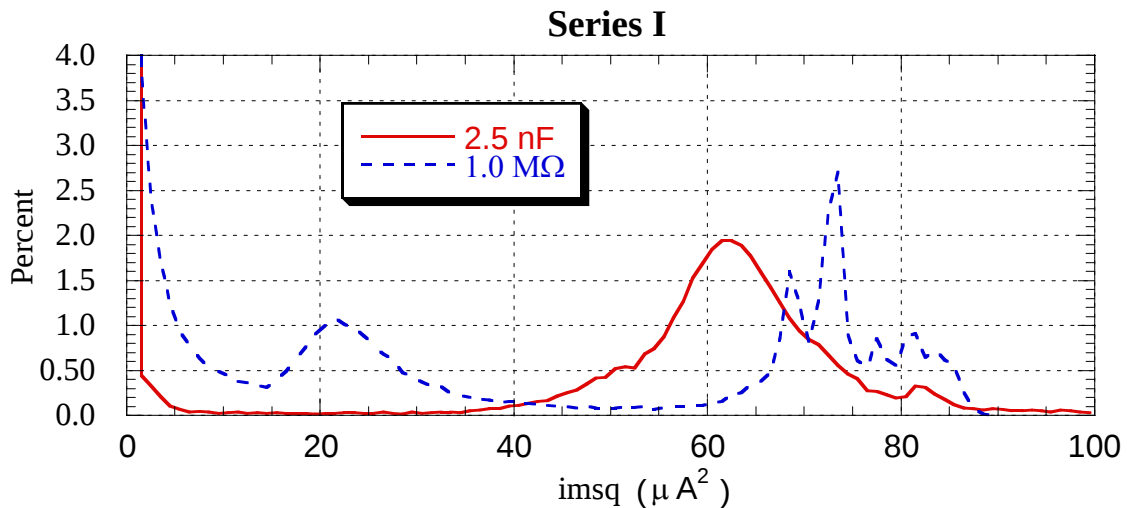
Figure 41. Series I:  $imsq$  histograms

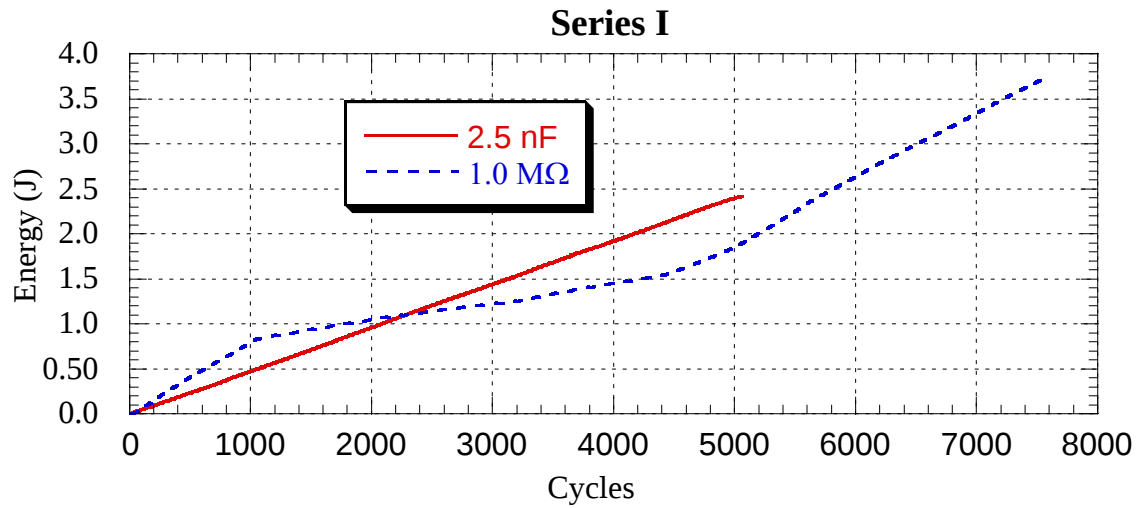
Figure 42. Series I: Energy vs. time-to-failure

An interesting observation noted from Figure 42, which is a plot of energy (J) versus time-to-failure in cycles, is that the power delivered to a resistance of  $1 \Omega$  (i.e., normalized to 1) corresponds to 475.6  $\mu W$  and 493.5  $\mu W$  for the 2.5 nF and 1.0  $M\Omega$  current limiting impedances respectively. These values are given in Table 20. Although no conclusions could be made whether this is a coincidence or of value that could be used to compare TTF of different cables.

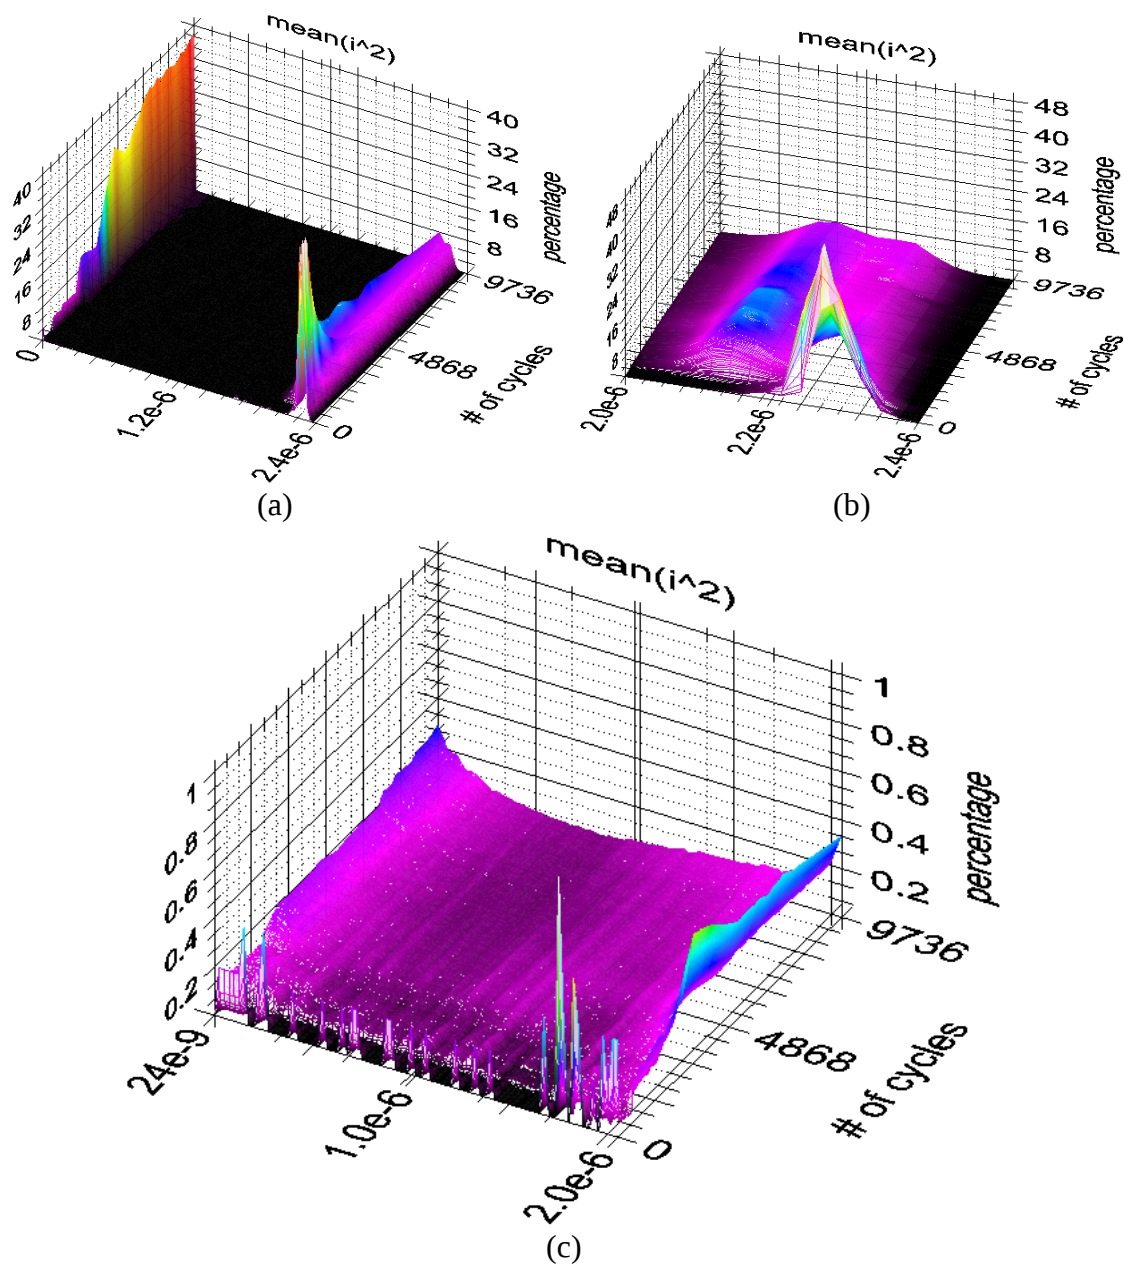
Figure 43. Series II:  $5.0\text{M}\Omega - j666\text{pF}$  *imsq* distribution (a) all, (b)  $2.0 \times 10^{-6}$  to  $2.4 \times 10^{-6}$ , (c)  $24 \times 10^{-9}$  to  $2.0 \times 10^{-6}$

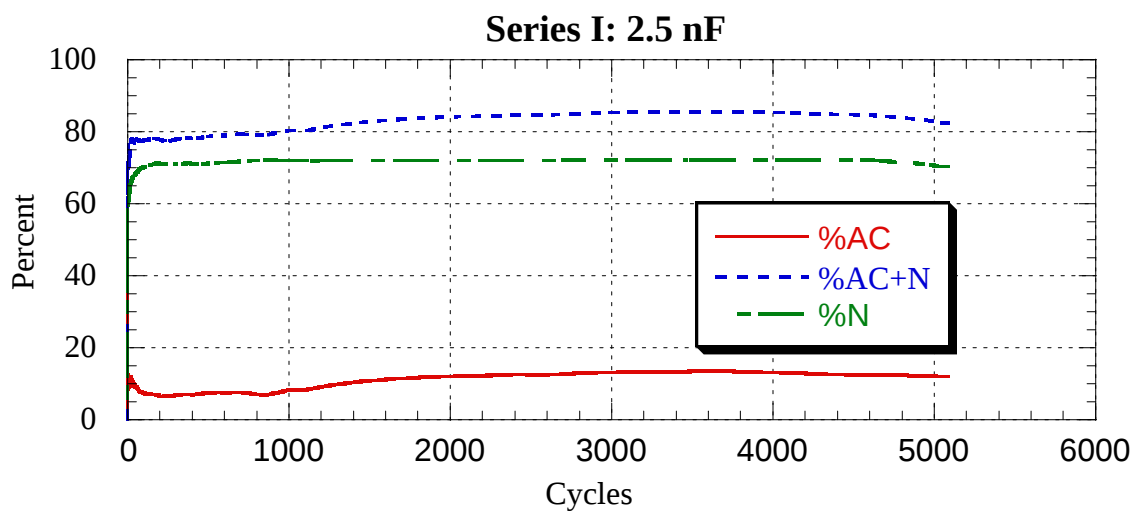
Figure 44. Series I: 2.5 nF, Percent vs. TTF of AC, Noise, and Arcing

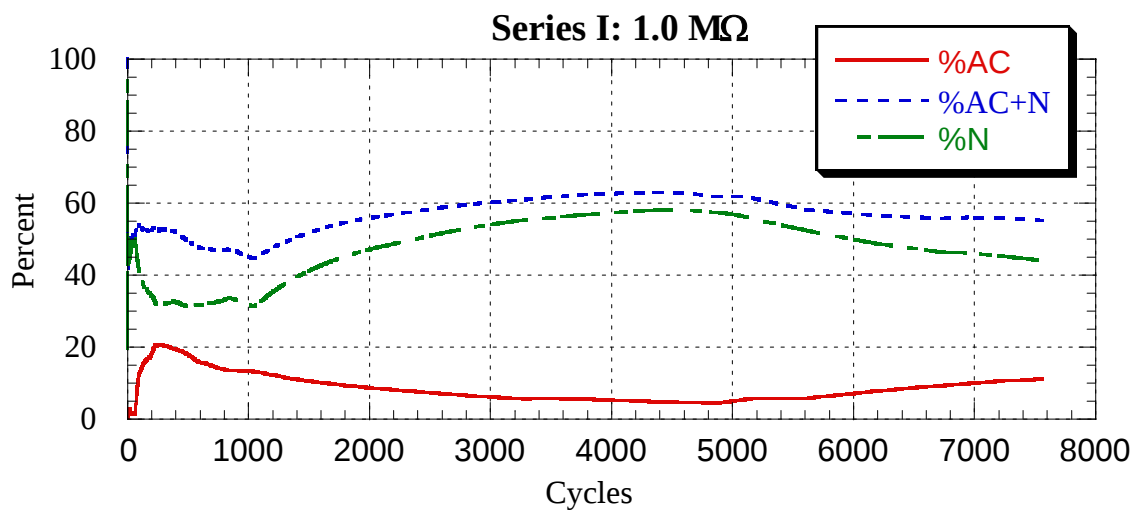
Figure 45. Series I: 1.0 MΩ, Percent vs. TTF of AC, Noise, and Arcing

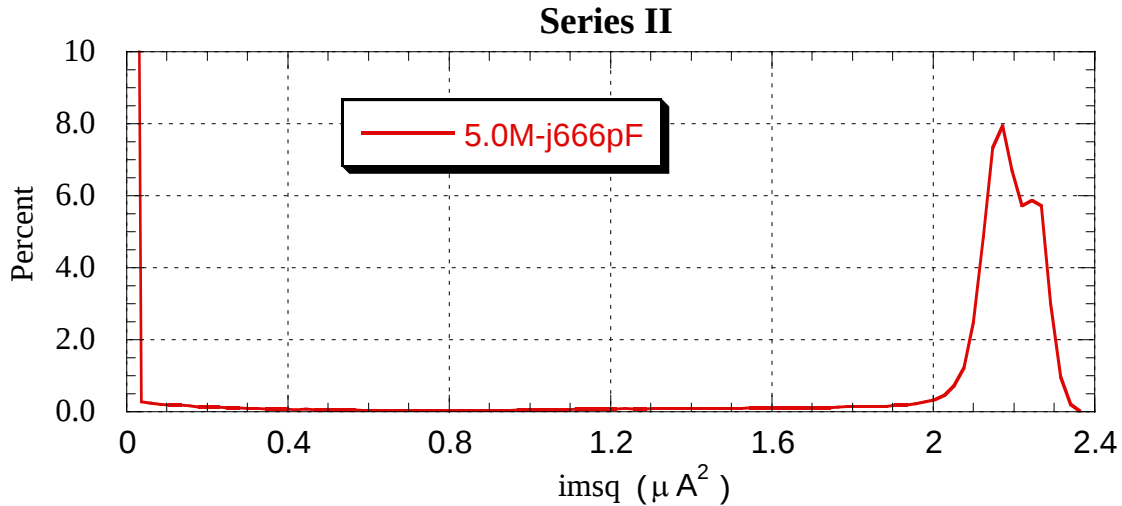
Figure 46. Series II: 5.0M $\Omega$  - j666pF percent vs. *irmsq* histogram

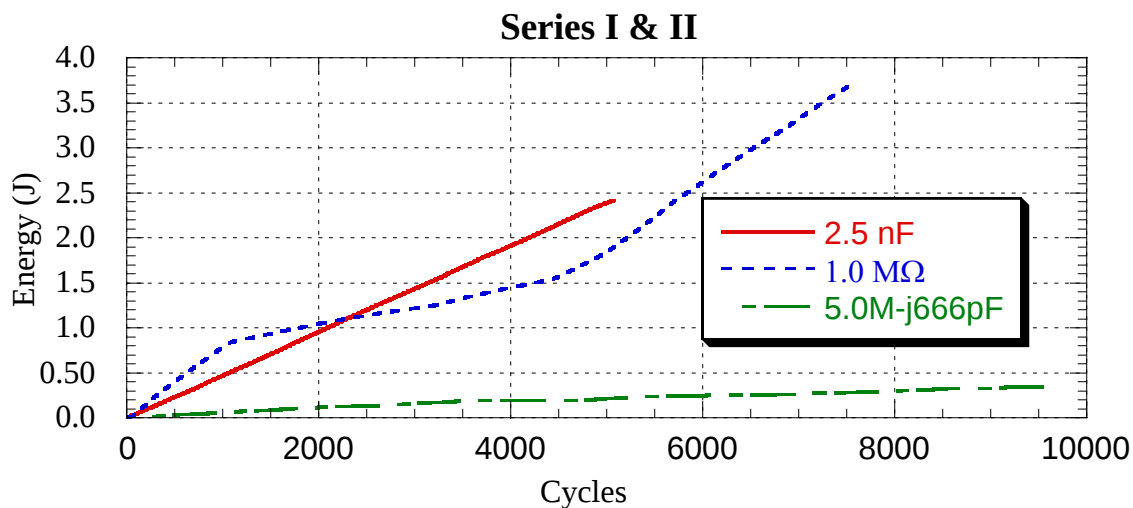
Figure 47. Series I and II: Energy vs. TTF comparison

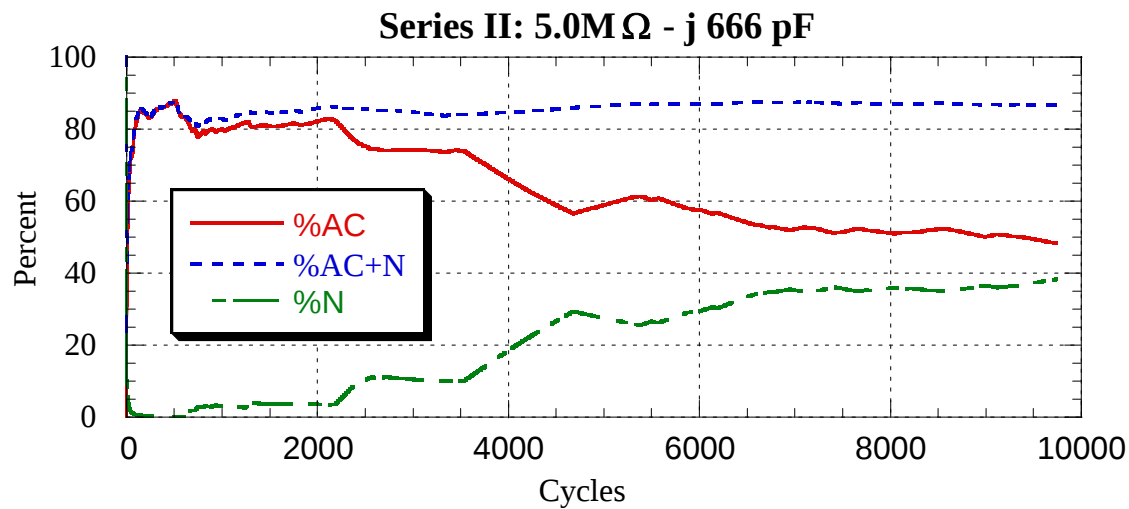
Figure 48. Series II: 5.0MΩ-j666pF, Percent vs. TTF of AC, Noise, and Arcing

The percentage of dry-band arcing events is shown in Figure 48. The plot shows that approximately 80 % to 90 % of the activity occur in the *AC* and *Noise period*. This also supports to the fact that the cable did not fail since a low percentage of the time arcing did not occur to cause enough damage to fail the cable. This also indicates that a small percentage of the energy developed between the electrodes was not related to dry-band arcing but to the *AC* and *Noise period* that do not cause considerable damage.

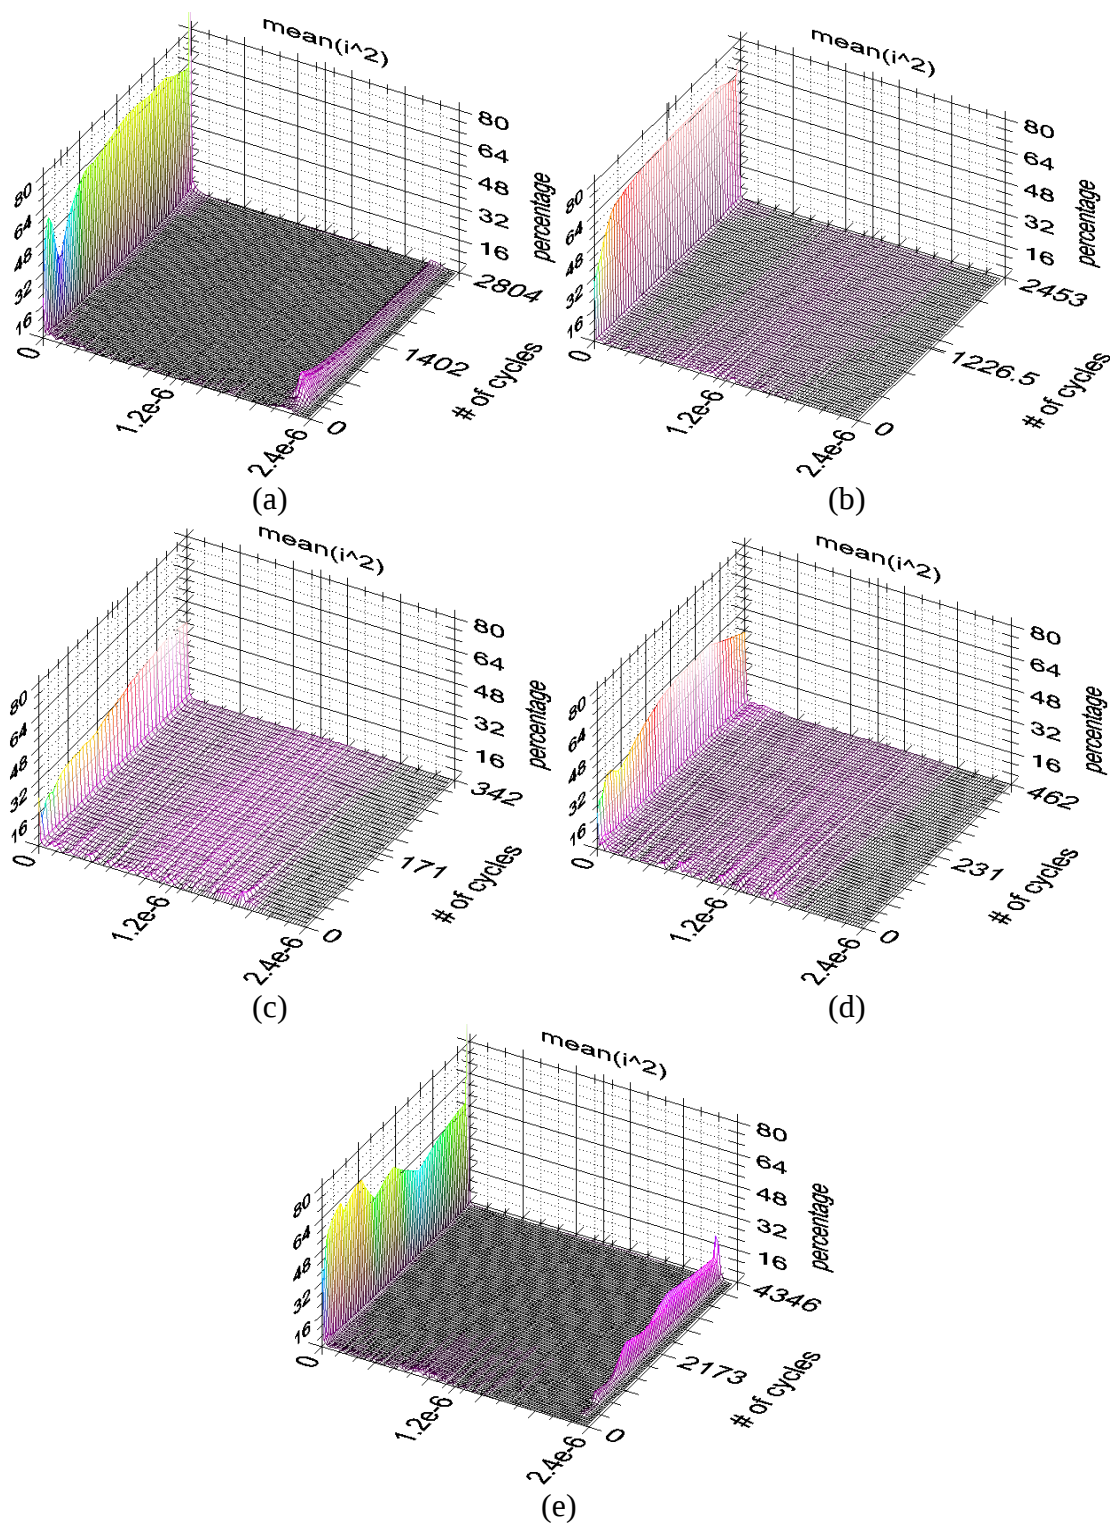
Figure 49. Series III:  $5.0\text{M}\Omega - j666\text{pF}$  (a) Run1, (b) Run2, (c) Run3, (d) Run4, (e) Run 5

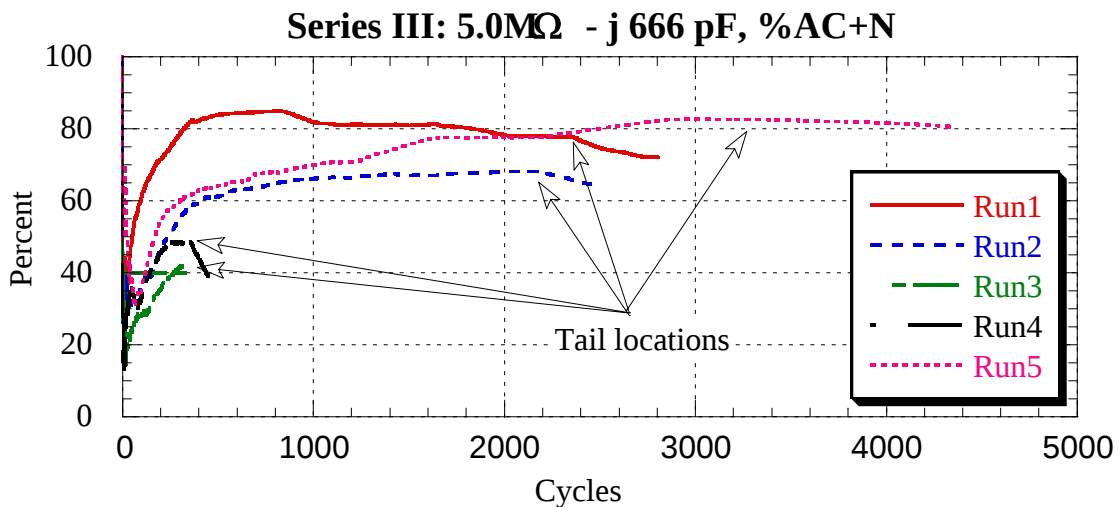
Figure 50. Series III: Percentage vs. TTF of *AC+N period*

The next plot shown in Figure 50 is the sum of *AC* and *Noise period* activity percentage versus TTF for Series III. All of the trajectories exhibit a peak value prior to cable failure. Also revealed in the trajectories is a *tail* with negative slope that is an indication of a breakdown in the cable's sheath. This corresponds to the fact that there is a continuous flow of leakage current through the cable's sheath as has been observed in prior experimental tests. Although, the leakage current during a failure is sinusoidal as categorized by the *AC period*, quantitatively they are different. The leakage current magnitude flowing during the failure is less than the *AC period* but greater than the *Noise period*. These characteristic indicators agree with the experiments performed and reported prior to this finding. The leakage current during the failure falls in the category of the *Arcing period* as defined by the activities respective value even though it is not really arcing in the strictest sense.

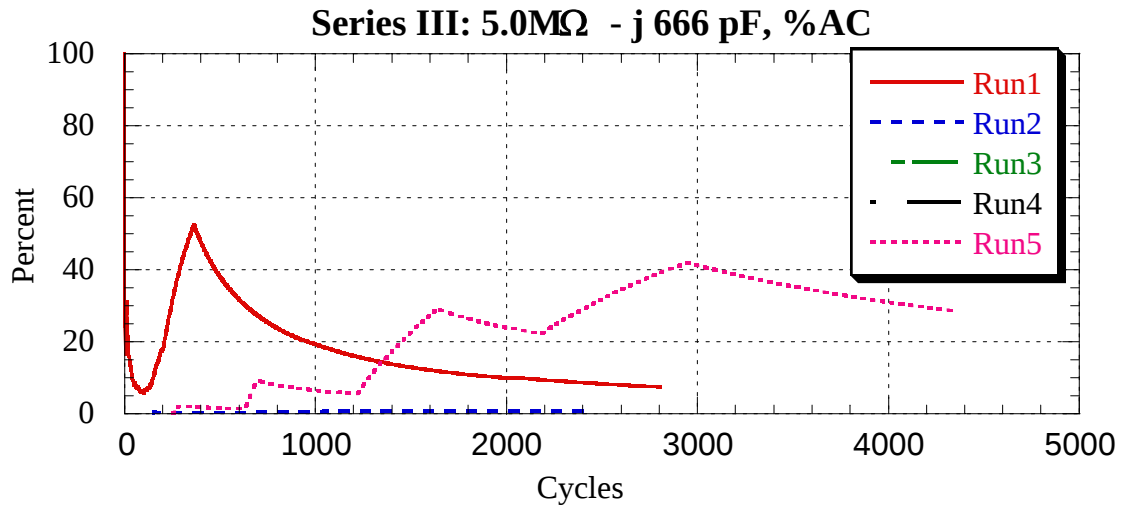
Figure 51. Series III: Percentage vs. TTF of *AC period*

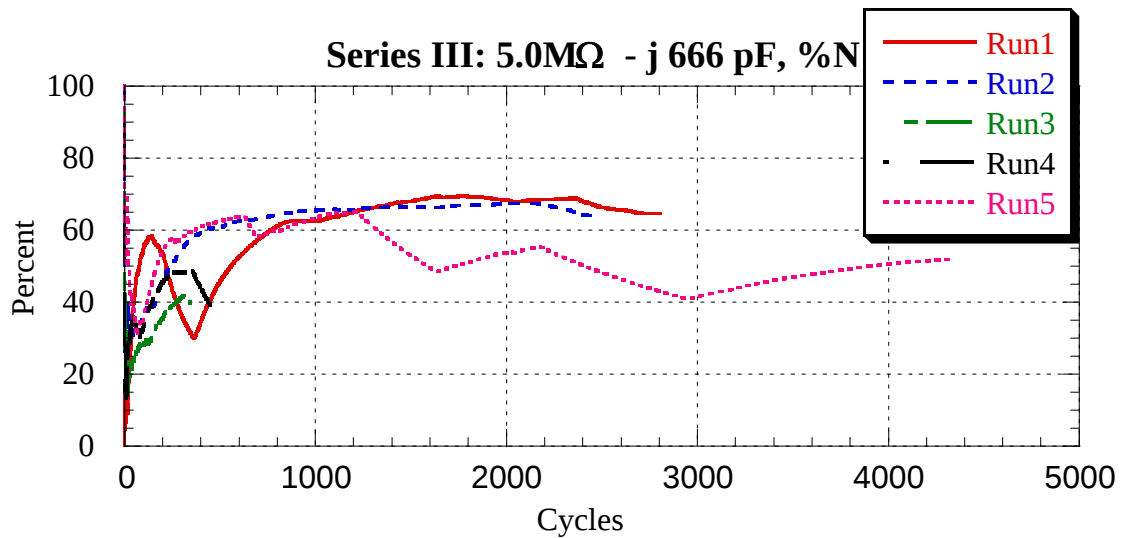
Figure 52. Series III: Percentage vs. TTF of *Noise period*

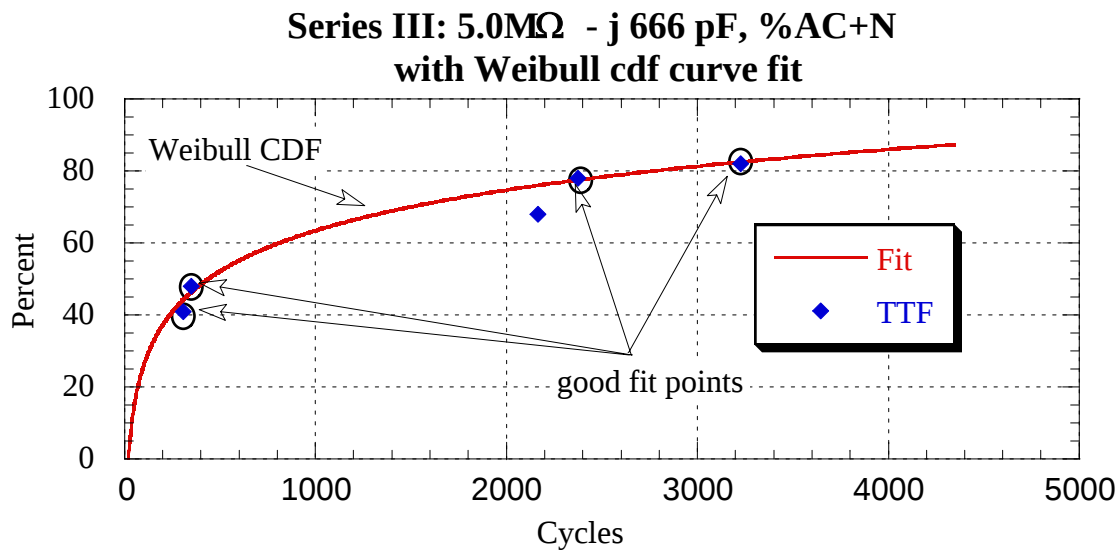
Figure 53. Weibull fit vs. TTF, Series 3

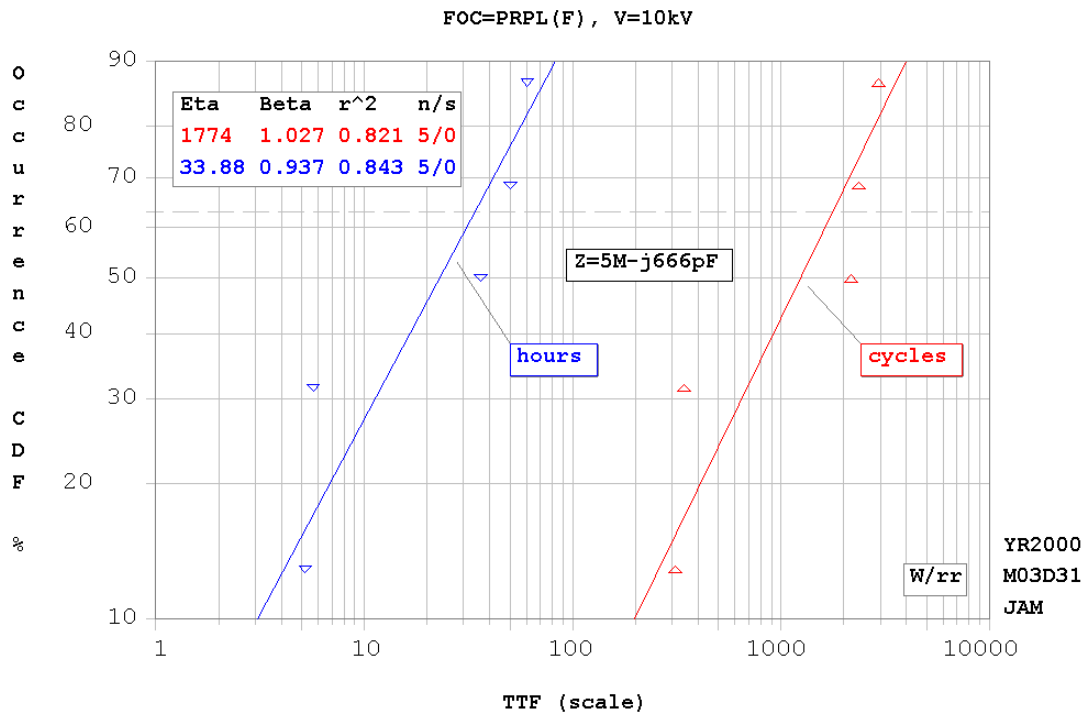
Figure 54. Weibull plot, Series III

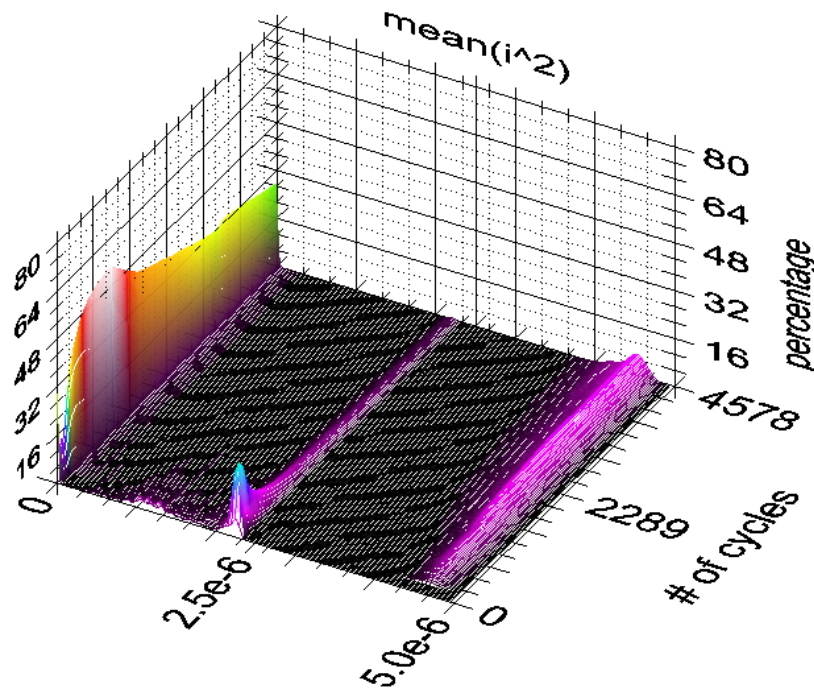
Figure 55. Series IV: 5MΩ-j666pF *imsq* distribution

The data file *test5.dat* of Series IV is lost and therefore not included in the analysis, although it is not a great loss. Another glitch in Series IV is the voltage was changed from 10 kV<sub>rms</sub> to 14.4 kV<sub>rms</sub> after *test2.dat*. The reason for this was because of the lack of arcing activity at the 10 kV<sub>rms</sub> level. By increasing the voltage level, it was presumed that the arcing activity would increase. The *imsq* distribution over time for Series IV is shown in Figure 55 and the histogram is shown in Figure 57. As for Series V, the *imsq* distribution over time is shown in Figure 56 and the corresponding histogram is shown in Figure 57. The main difference between the two *imsq* running histograms is that for Series V there is minimal *AC period* activity, and the cable failed in this test. Figure 56 (b) shows the arcing activity of the *imsq* distribution from the range of 50 nA<sup>2</sup> to 5 μA<sup>2</sup>.

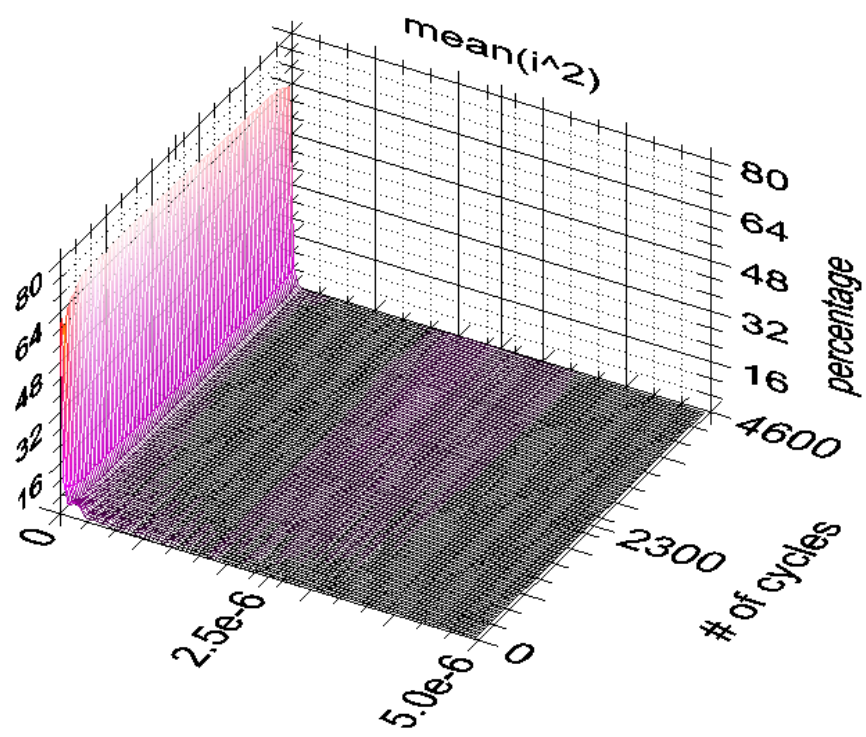
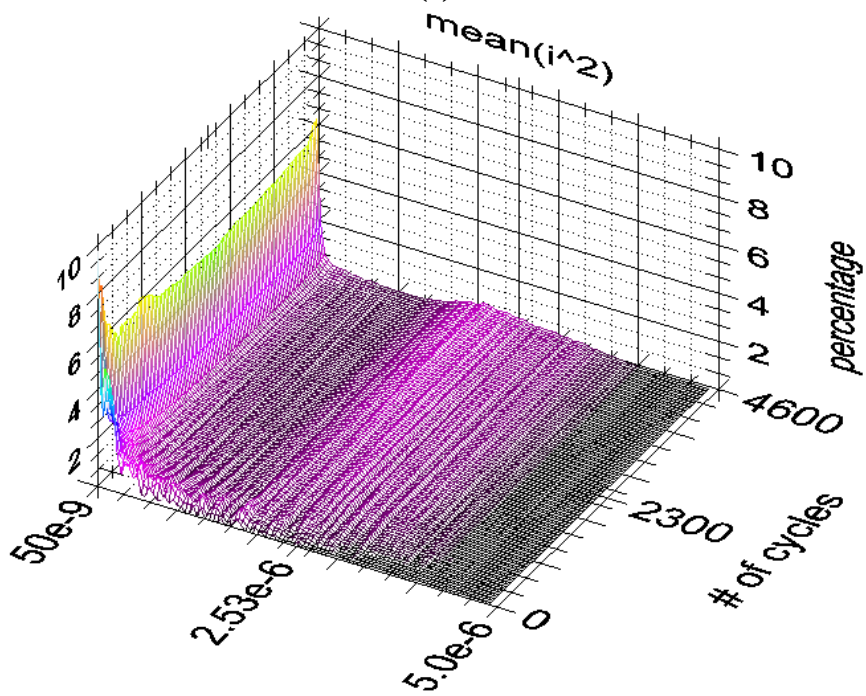
Figure 56. Series V:  $5\text{M}\Omega$ - $j666\text{pF}$  *imsq* distribution (a) all, (b)  $50\text{e-}9$  to  $5.0\text{e-}6$

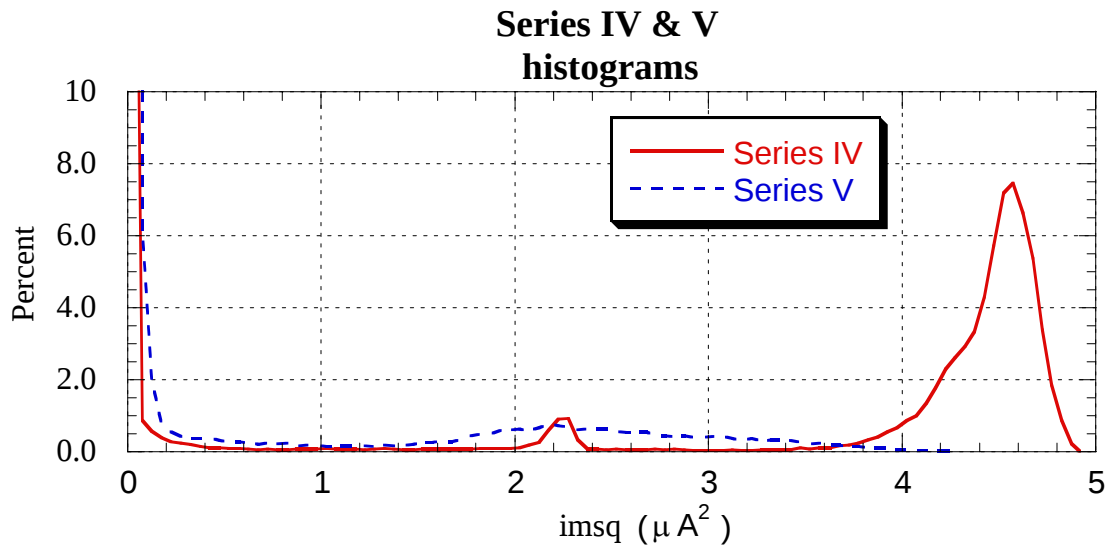
Figure 57. Series IV and V: Percent vs. *imsq* histogram 5M $\Omega$ -j666pF

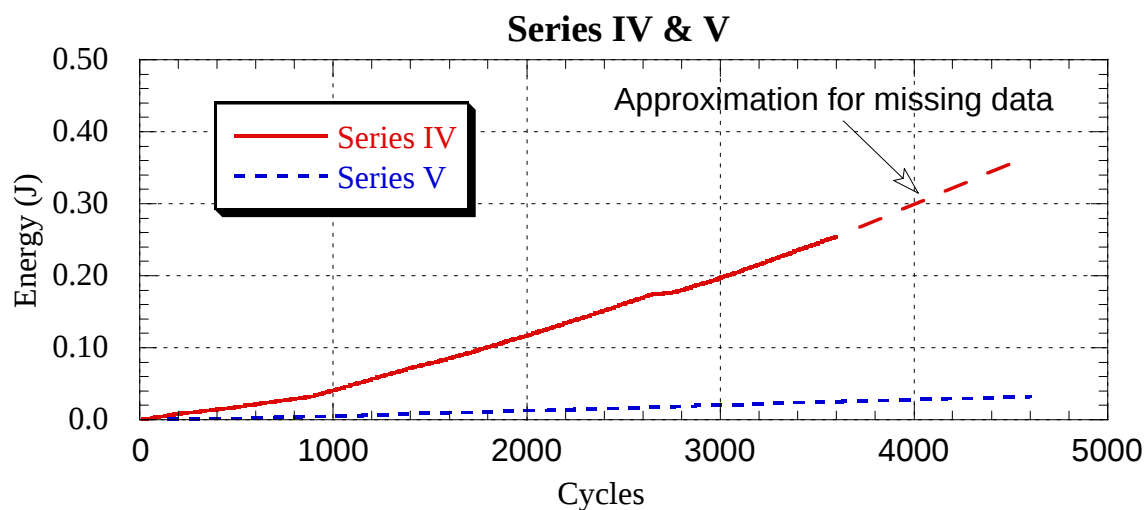
Figure 58. Series IV and V: Energy vs. TTF comparison

From the energy versus TTF plot in Figure 58, it is obvious that a higher energy is not an indication of failure directly. The trajectory of Series IV in Figure 58 may be extrapolated to the actual number of cycles, 4578. The final energy value, assuming the same rate as shown, would be between 360 mJ and 400mJ. The plot in Figure 59 shows the percentage of *AC+Noise period* versus TTF. TTF is the number of spray cycles. Not much can be concluded from the *AC+Noise period* percentage plot due to reason that two different spray techniques were used.

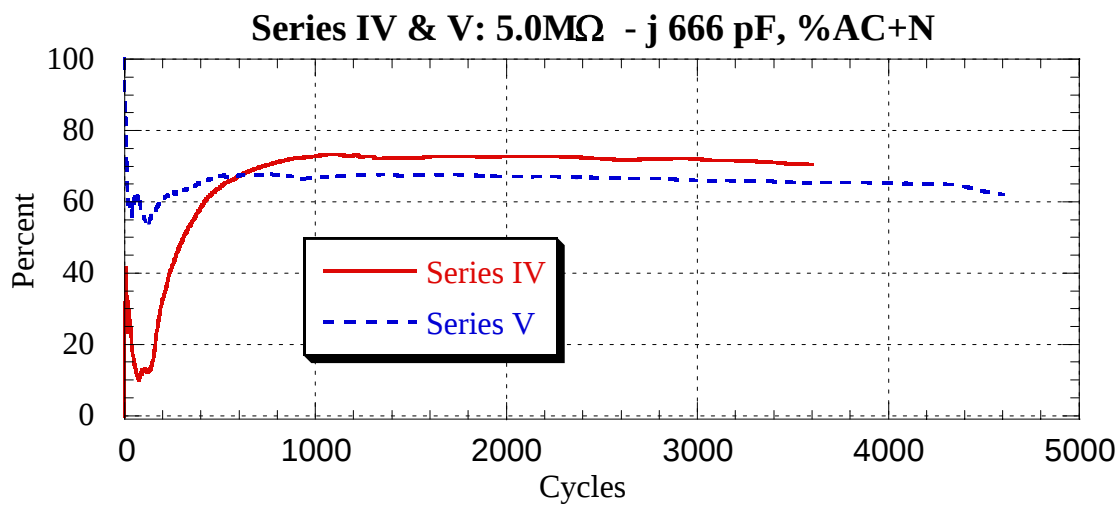
Figure 59. Series IV and V: Percentage vs. TTF of AC+Noise period

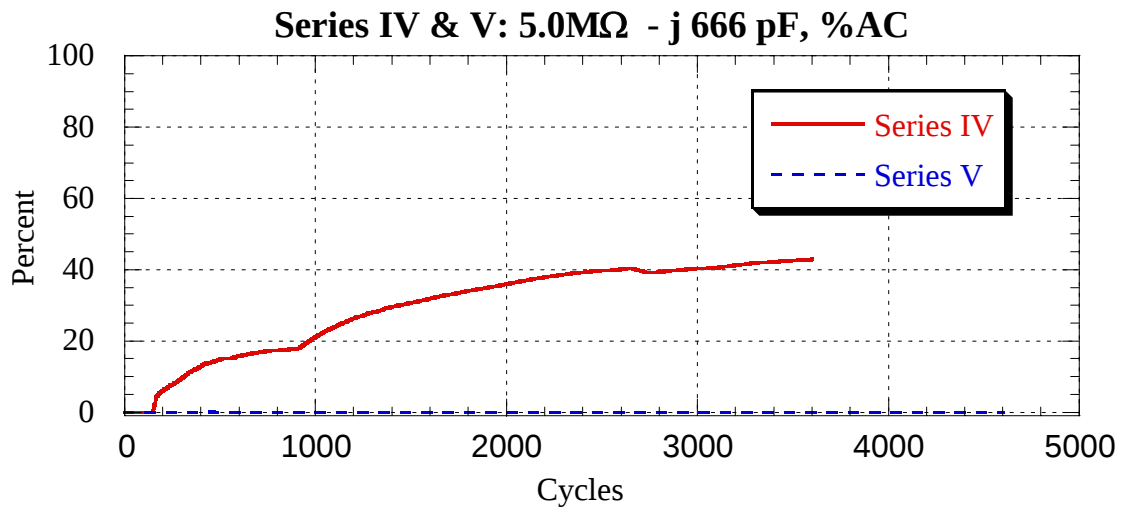
Figure 60. Series IV and V: Percentage vs. TTF of *AC period*

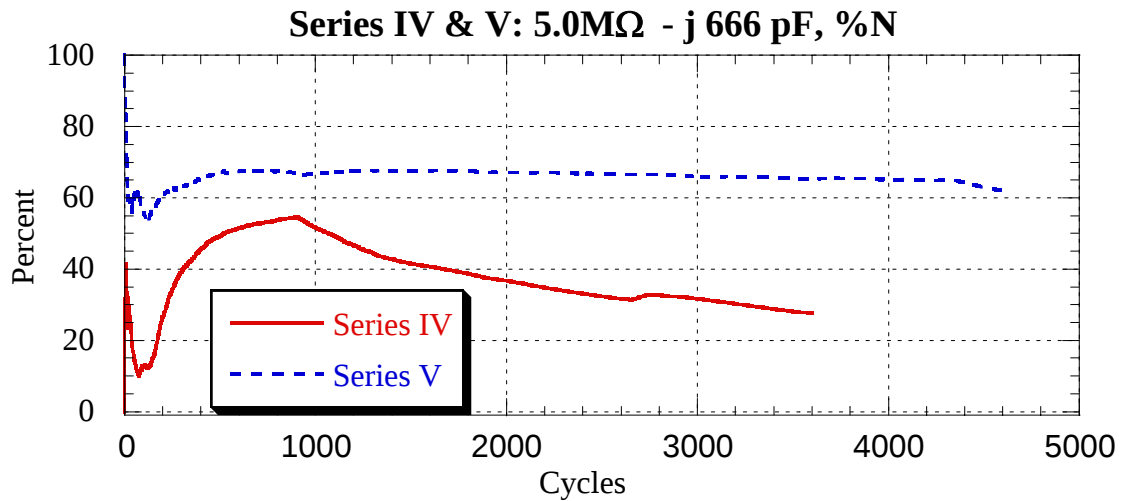
Figure 61. Series IV and V: Percentage vs. TTF of *Noise period*

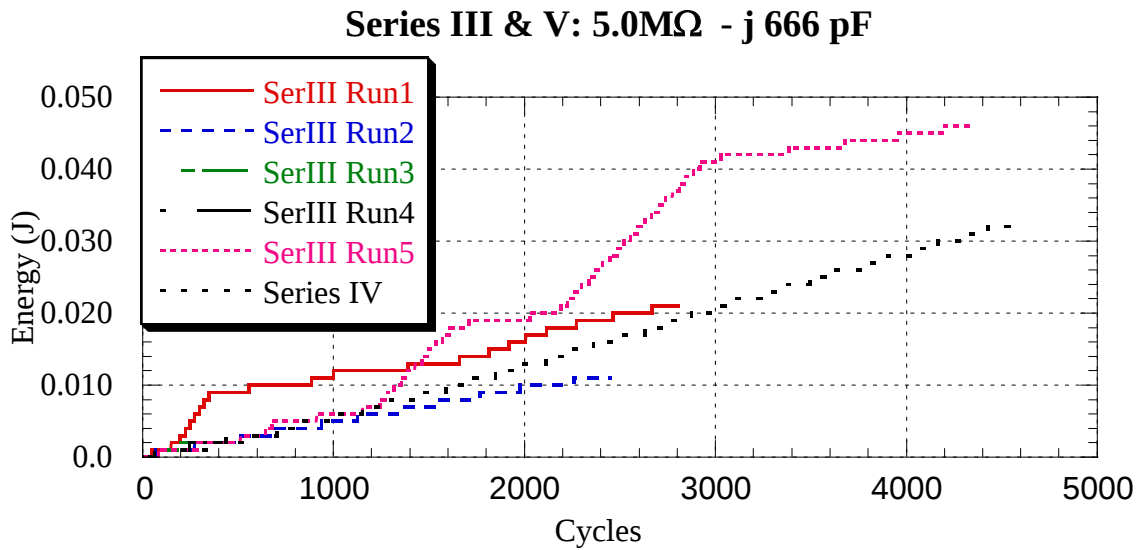
Figure 62. Series III and V: Energy vs. TTF comparison

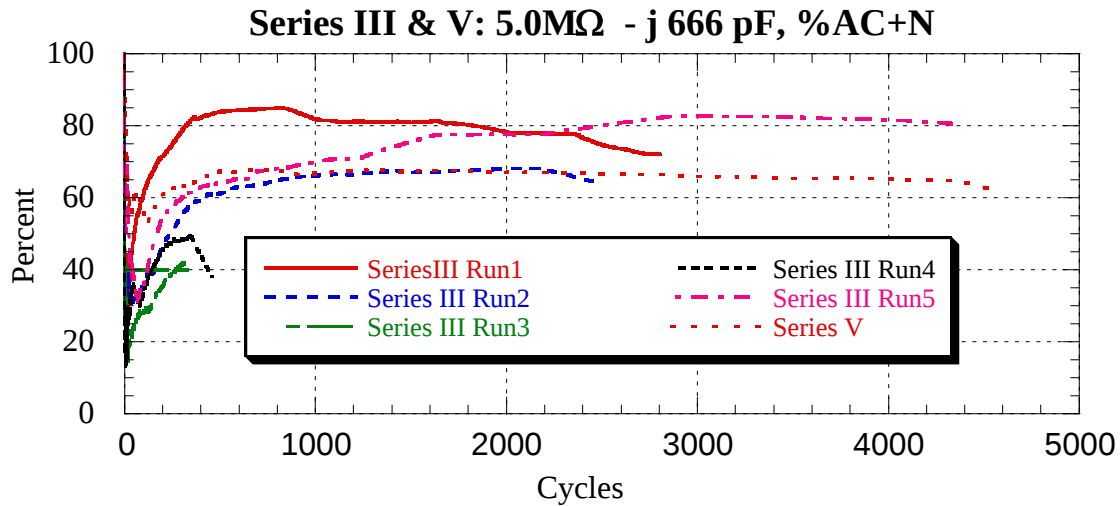
Figure 63. Series III and V: Percentage vs. TTF of AC+Noise period

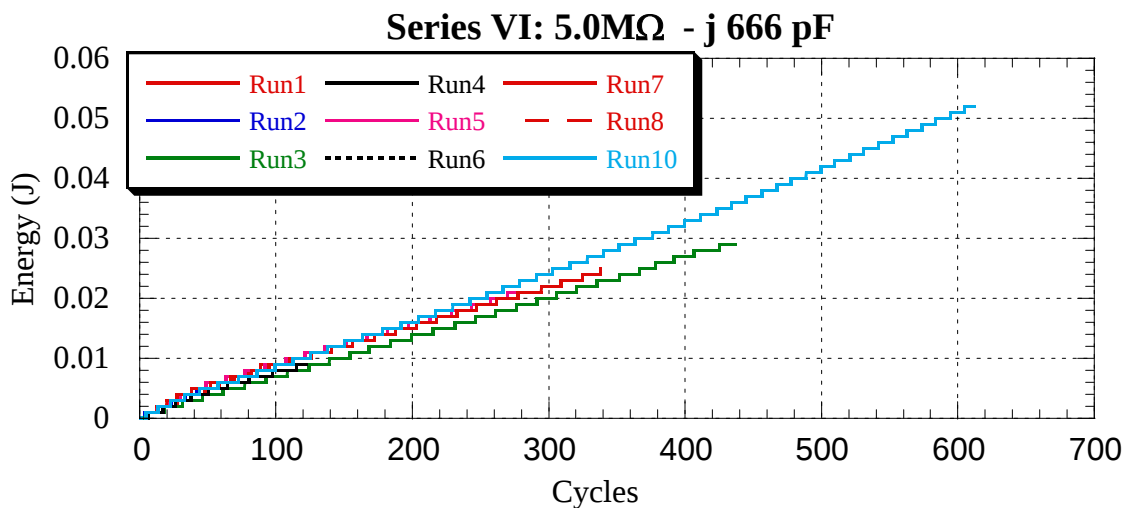
Figure 64. Series VI: Energy vs. TTF comparison

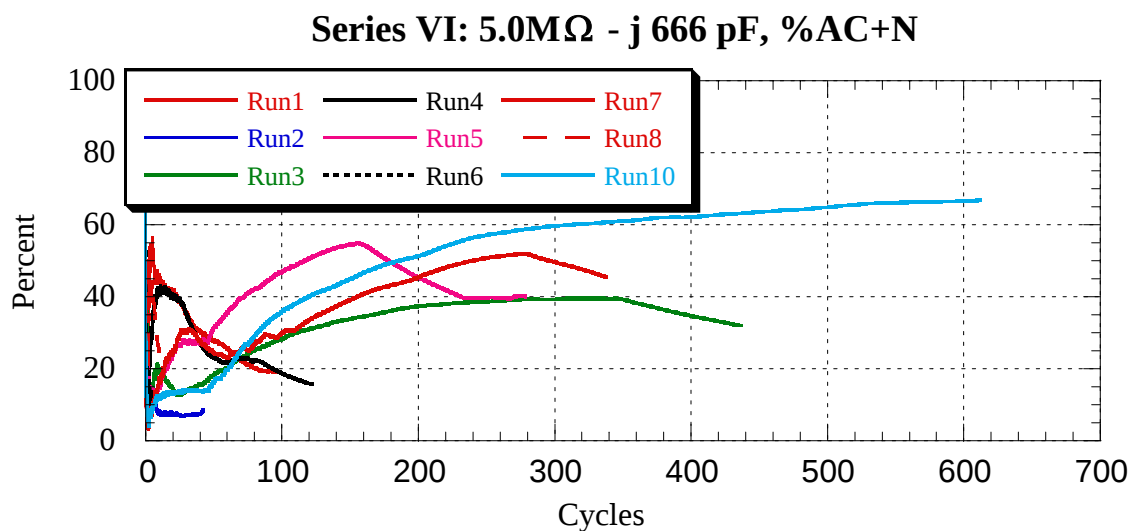
Figure 65. Series VI: Percentage vs. TTF of AC + *Noise period*

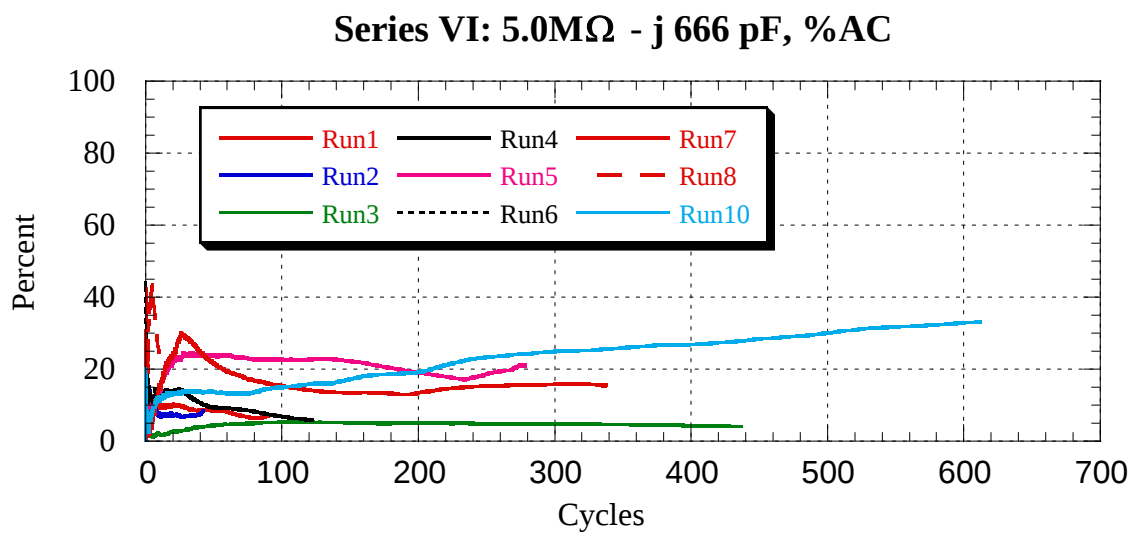
Figure 66. Series VI: Percentage vs. TTF of AC *period*

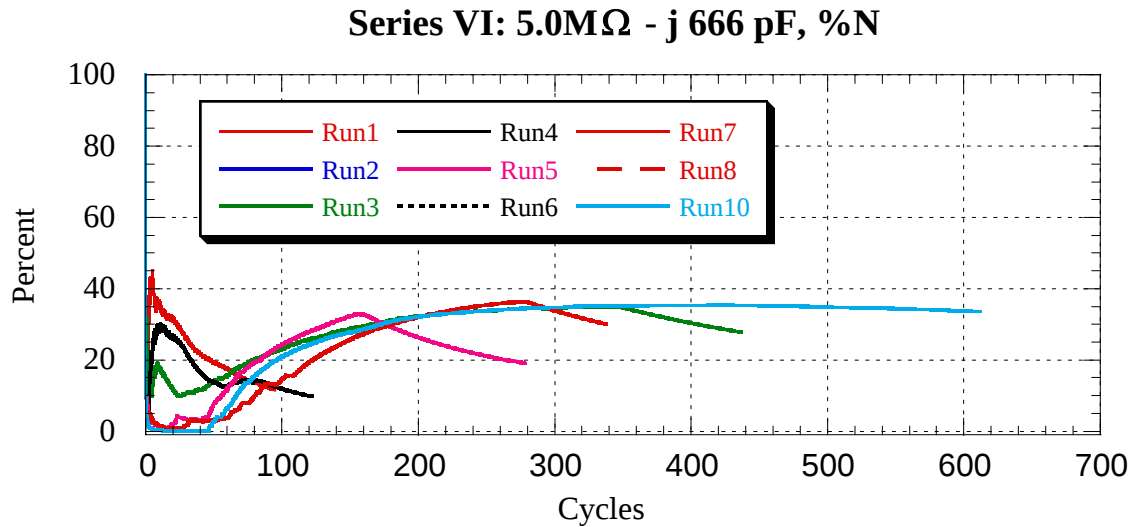
Figure 67. Series VI: Percentage vs. TTF of *Noise period*
