# **Assessing Deterioration of ADSS Fiber Optic Cables Due to Corona Discharge**

*Final Project Report*

George G. Karady, Project Leader  
Johnny Madrid, Researcher  
Arizona State University

PSERC Publication 02-17

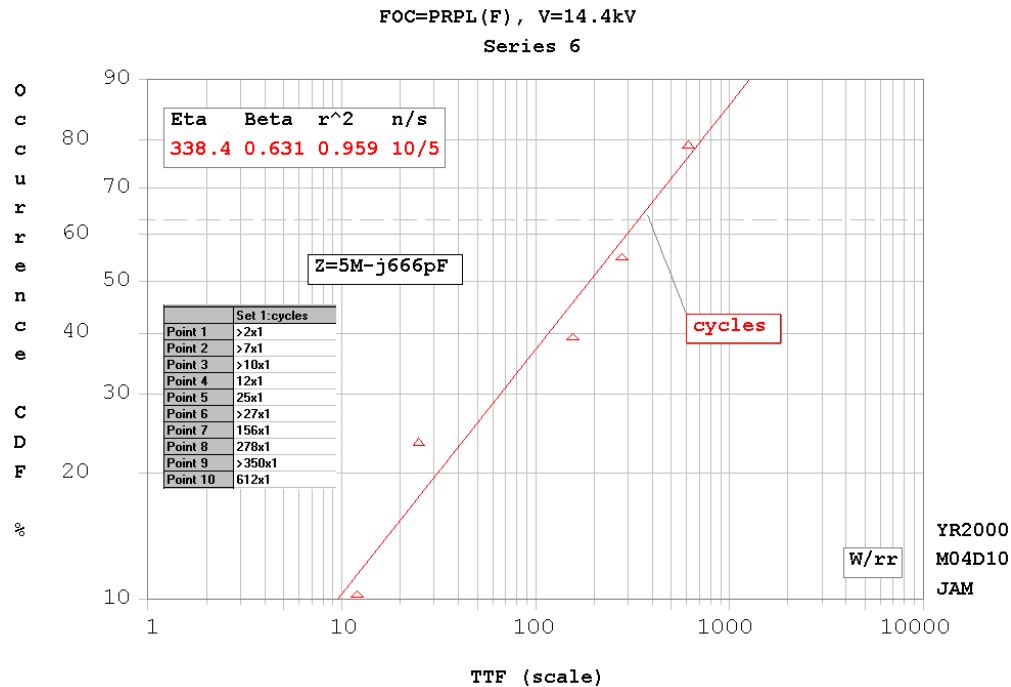
Figure 68. Series VI: Weibull plot with suspensions

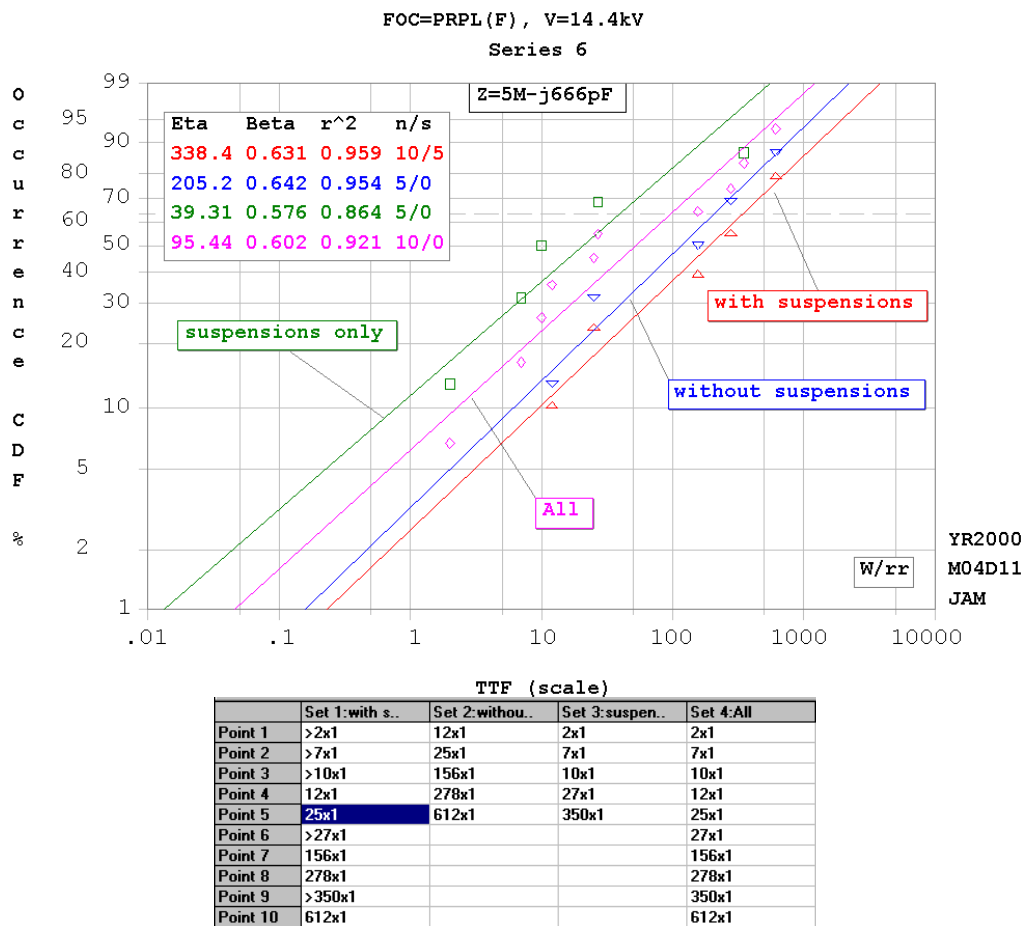
Figure 69. Weibull plot of various failure modes, Series VI

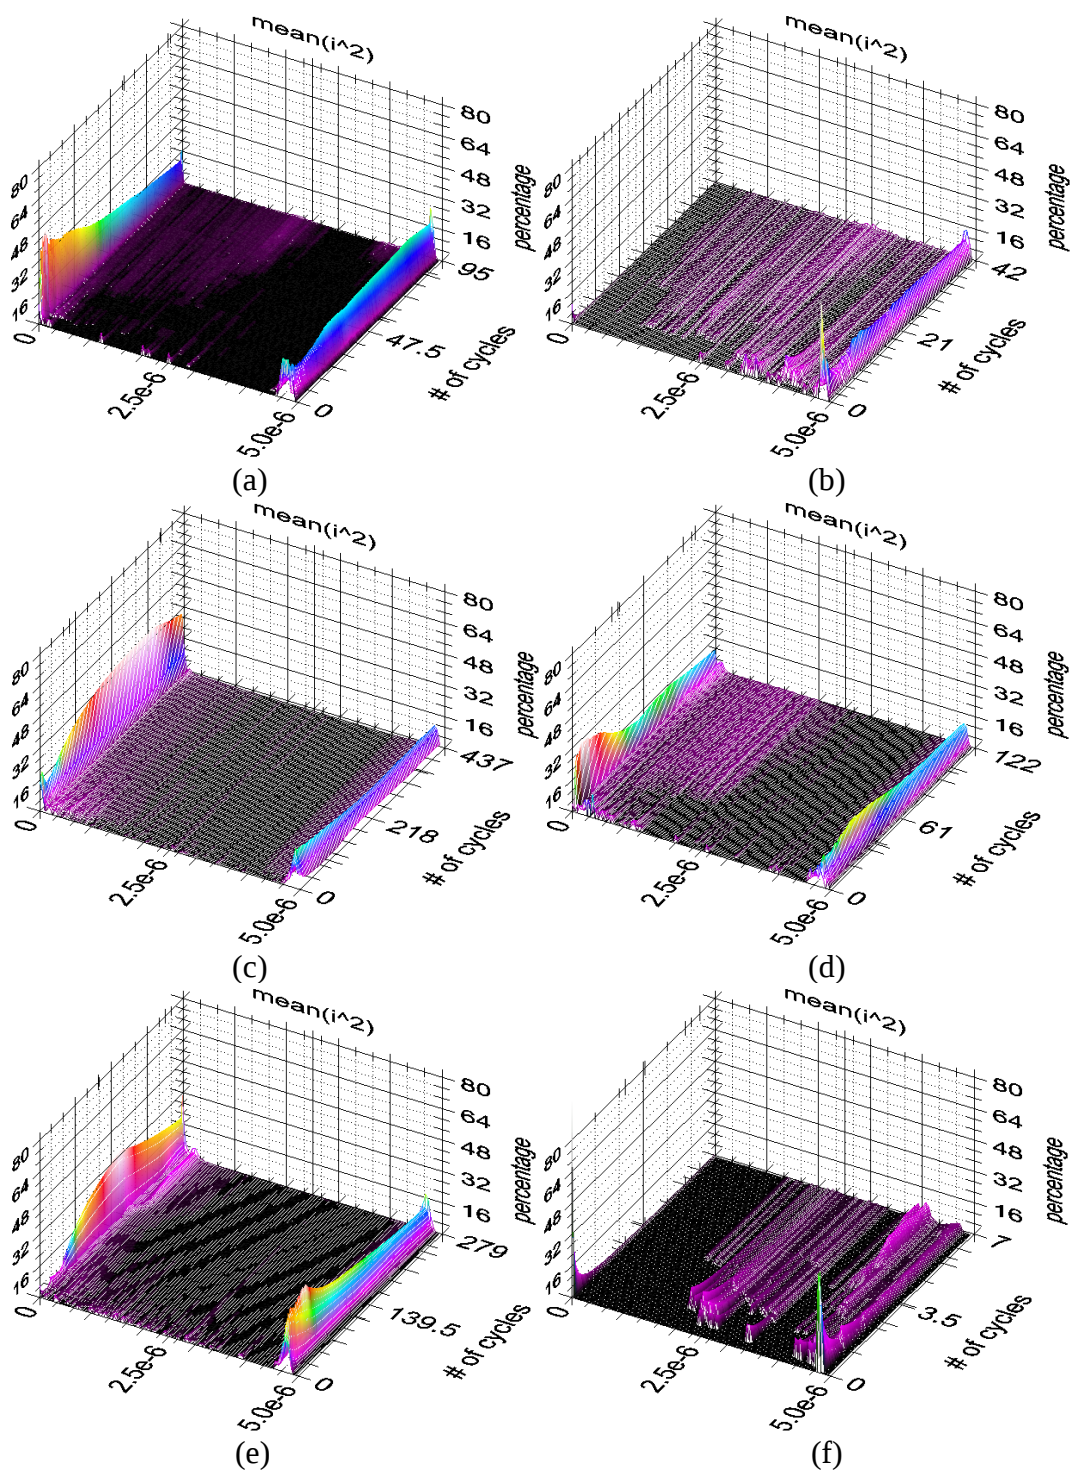
Figure 70. Series VI: *imsq* distribution, (a) Run1, (b) Run2, (c) Run3, (d) Run4, (e) Run5, (f) Run 6

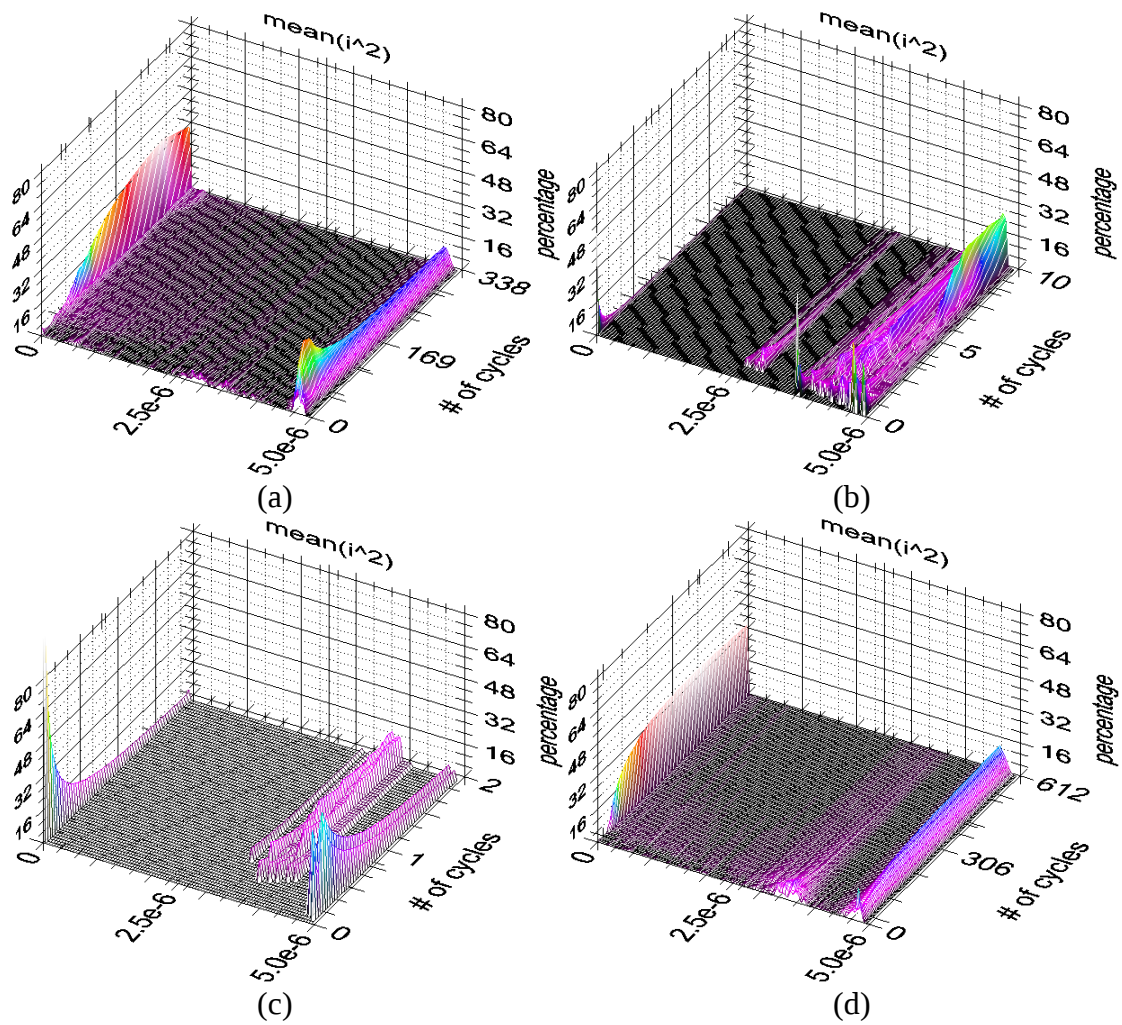
Figure 71. Series VI: *imsq* distribution, (a) Run7, (b) Run8, (c) Run9, (d) Run10
